Soil Stabilizers On Universally Accessible Trails

Roger Bergmann
Mechanical Engineering Technician

USDA Forest Service

September 2000

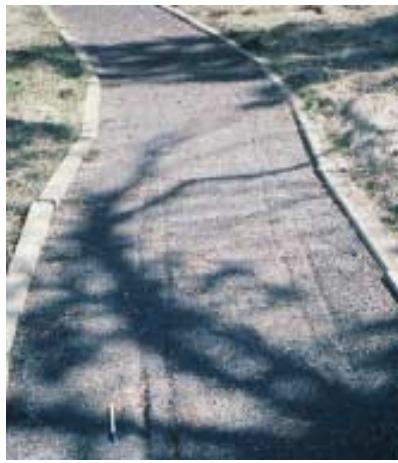
shaded areas, but the trail itself was free of snow. This section of trail was saturated with water, and it was apparent from the visible ruts that a wheelchair user had recently been on the trail. (See figure 3). Even though there were no obvious signs that a wheelchair had traveled from the parking area over the trail constructed with Road Oyl® (described later in this report), there were 1-inch (25.4 millimeters) deep ruts created by the chair wheels beginning at the start of the EMC² section and continuing through the entire length of the EMC² section. As the trail dried out through the spring and summer, the surface did not harden. Later in the summer, it was possible to easily scrape 2 inches (50.8 millimeters) through the surface with the edge of a boot. When John Parker did his trail evaluation, he found the trail to have a soft surface and it was not easy to push his wheelchair over. He felt that the surface was all right for a short distance, but he would not want to travel far on that type of surface.

Figure 3. Visible ruts on trail.

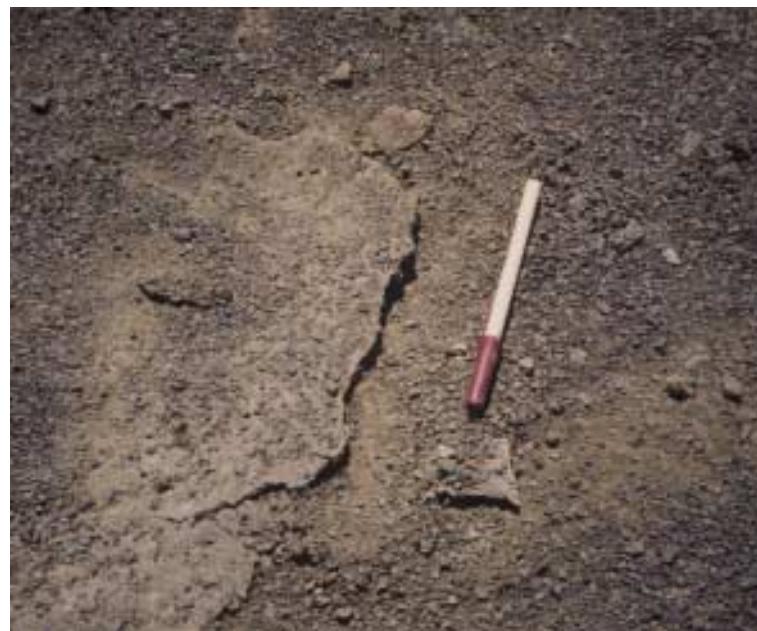
After 5 winters, there has been one small section about 1 square foot (0.1 square meters) in size that has cracked and begun to flake up on one edge. This crack shown in figure 5 developed over the second winter, and no attempt to repair it was done in order to see if the area would get worse over time. It did not develop into a more serious defect, and it is expected that a repair could be done fairly quickly by removing all of the loose surface material, wetting the surface, mixing the proper amount of ROAD OYL into a "fine" aggregate, placing it into the damaged area, and compacting.

Figure 5. Crack that developed in trail after second winter.

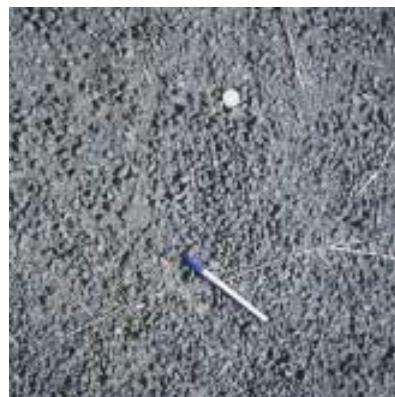
The macadam sections of this project were completed in late September 1994. Over the years, most of the blotter sand had been blown off of the trail surface. (See figure 6). In August 1998, John Parker rated most of this trail very low because the exposed pea gravel created a consistently bumpy ride in the wheelchair. There was also a distracting crunching sound as the wheels traveled over the surface. Structurally the surface was very firm and stable, and with maintenance of the sand surface

the problems of noise and bumpy ride for a wheelchair user would probably be resolved.

Figure 6. Macadam surface with blotter sand blown away.

The macadam construction method did provide a firm surface though there was a considerable amount of surface raveling of the pea gravel. Regular maintenance of the blotter sand top surface may solve the problems of raveling, noise, and bumpy ride.

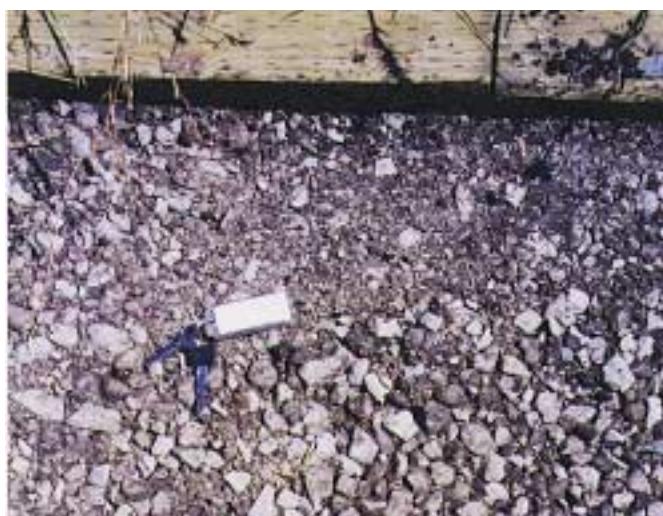
Figure 7. Coarse materials and loose surface rocks make it difficult to turn the wheels on a chair or walker.

To achieve a firm and stable surface it is recommended that one use fine aggregate (3/8-inch minus; 9.53-millimeters minus), rather than coarser aggregate that can cause problems for individuals using mobility aids. If a surface with coarse materials has any raveling, the loose surface rocks can make it very difficult to turn the wheels on a chair or walker. Loose surface rocks can also make placement of canes or crutches very difficult. (See figure 7.) Two types of fine aggregate material that are not suitable for accessible trails are sand and pea-size gravel. Both of these materials create surfaces that are very difficult to move a wheelchair across. Sand does not have any large particles (1/2-inch, 12.7-millimeters) to help keep the wheels from sinking into the soft surface, and pea-size gravel does not have enough interlocking surfaces or any fine material to give the pea-size gravel stability. A well graded mixture from 3/8-inch (9.53-millimeters) down through the very fine material is what is needed.
