National Trail Surfaces Study

Final Report

February 2014

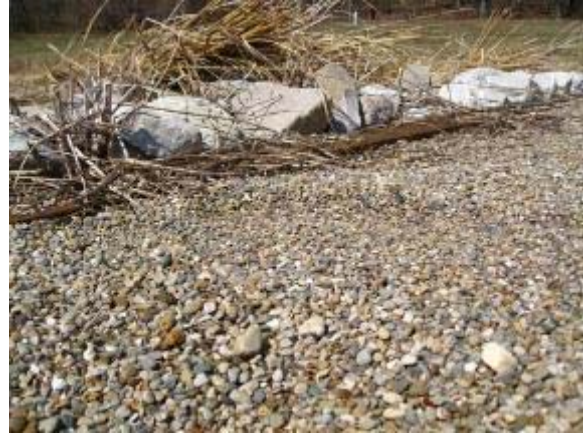
Photo 14 Klingstone loose fines coming to surface. March 17, 2009.

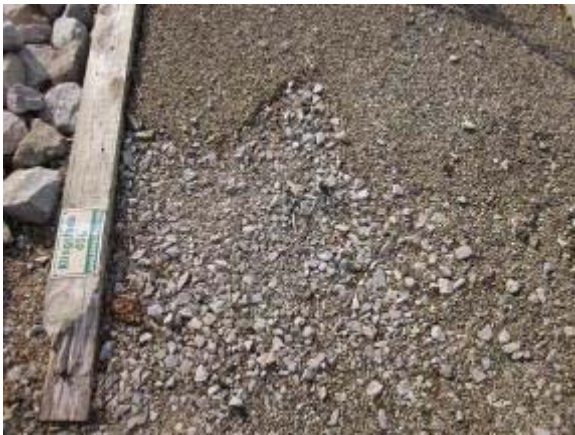
Photo 15 Klingstone at beginning of trail segment has started to wash out. November 22, 2011.

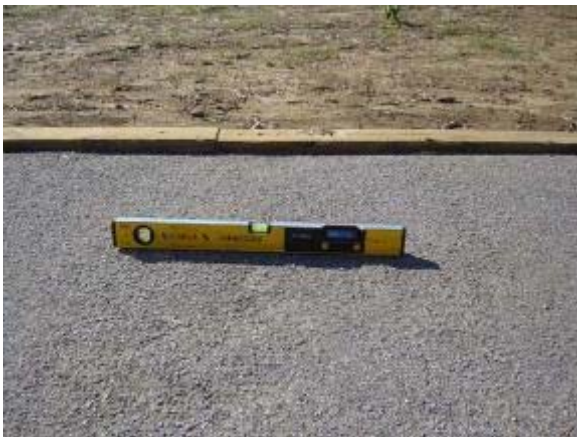
Photo 77 Stabilizer trail segment shows loose fines at top of surface. July 6, 2007.

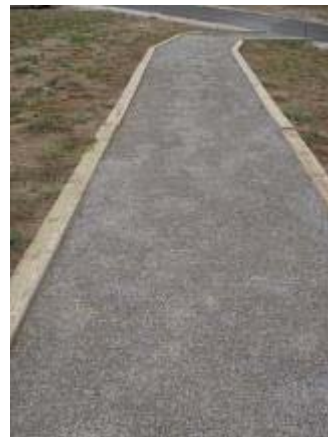
Photo 78 Stabilizer trail segment shows loose fines at top of surface. October 19, 2007.

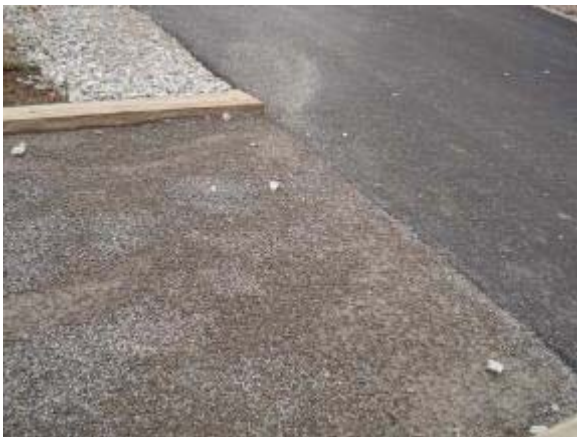
Photo 79 Stabilizer trail segment shows loose fines at top of surface. October 19, 2007.

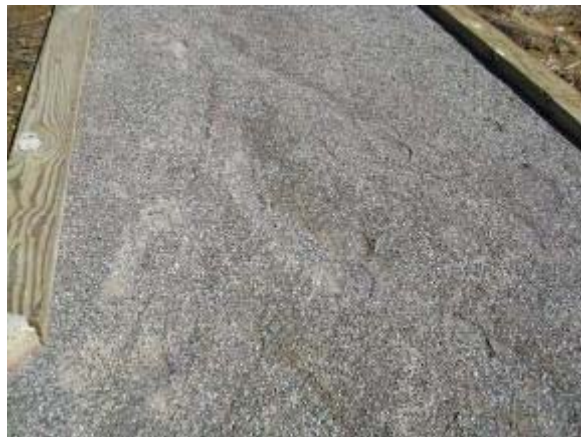
Photo 80 Stabilizer trail segment has runoff from heavy rainfall. March 13, 2008.

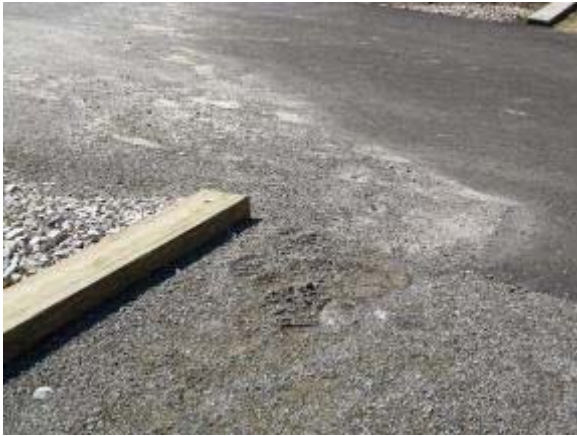
Photo 81 Stabilizer trail segment shows loose fines from heavy rainfall. March 13, 2008.

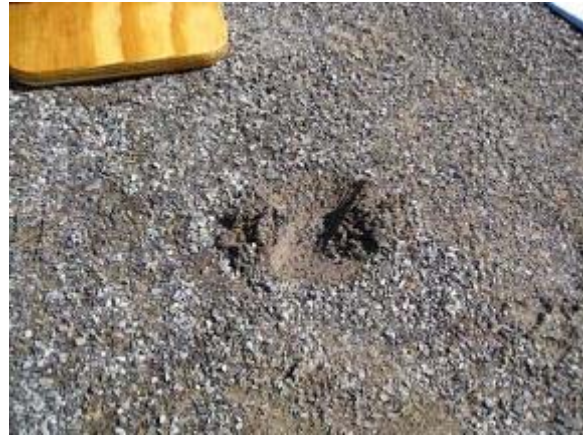
Photo 82 Stabilizer trail segment shows indentation from surface testing. March 13, 2008.

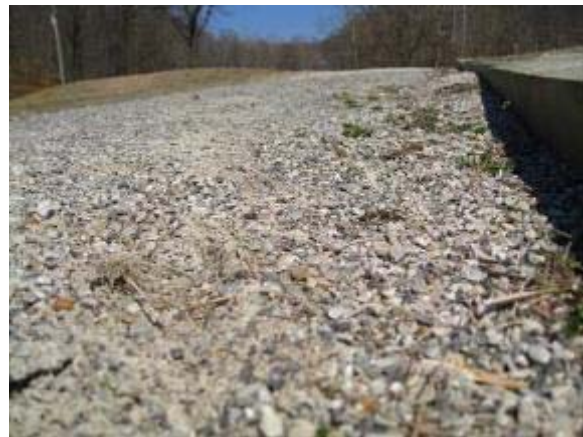
Photo 86 Stabilizer trail segment shows deterioration from runoff along timber edging. March 17, 2009.

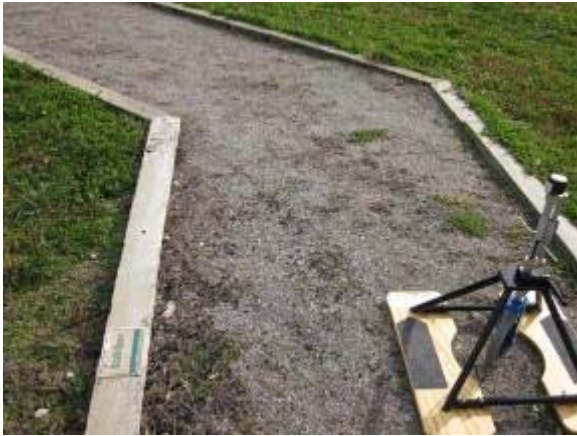
Photo 87 Stabilizer trail segment shows deterioration. November 2, 2011.

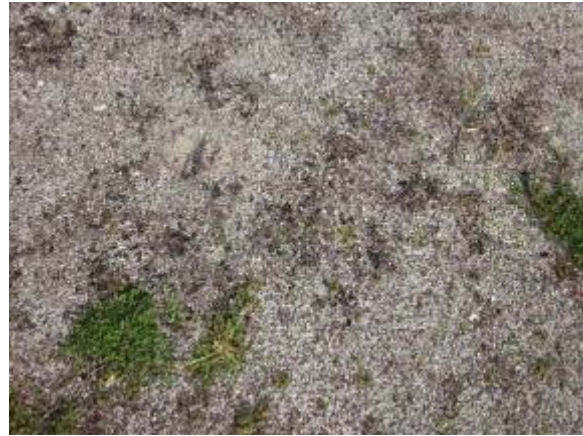
Photo 88 Stabilizer trail segment shows deterioration in middle of the trail. November 2, 2011.

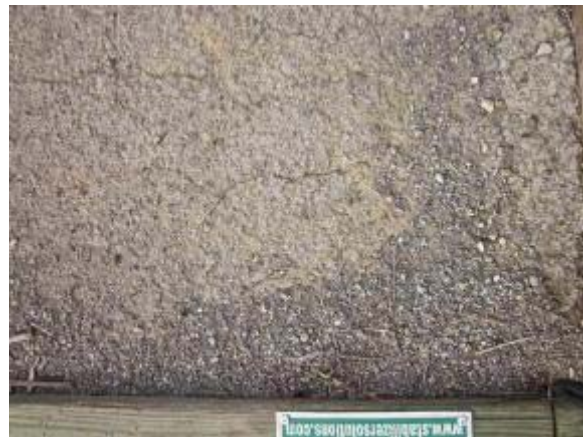
Photo 105 StaLok trail segment shows cracking next to timber edging. November 2, 2011.

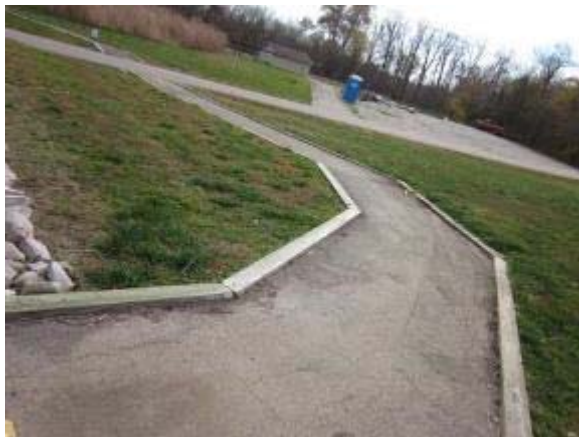
Photo 106 StaLok trail segment had some pooling of water at lower points of the surface. November 2, 2011.

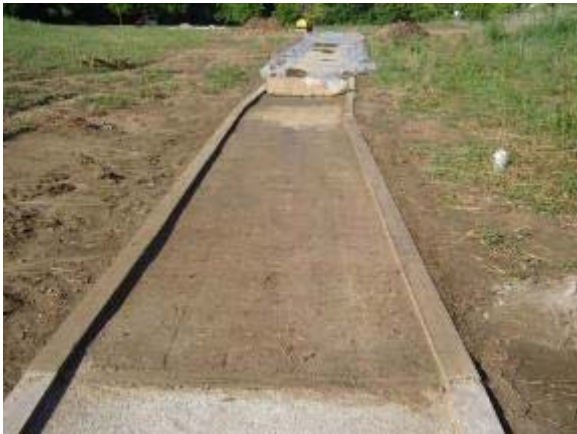
The trail segment is composed of the stabilizer, Polypavement and is 5 feet wide by 30 feet long. The segment contains timber edging. The Polypavement is applied to a base of compacted native soils and is then mixed into an additional 2 inches of tilled soil. The surface started to show signs of cracking, sinking

and softening after the first round of tests when the temperature was still mild and warm (June – August; 100 degree temps). After uncharacteristically heavy rainfall, the surface became the same texture as mud. Upon drying up, the surface remained cracked and was heaving along the full width of the trail. The material just under the surface of the segment, contains cracks and heaving and stayed wet and therefore soft under foot. NCA continued to test the surface to ensure consistency in data collection, despite the initial impression that the Polypavement application was not maintaining itself. It appeared that the top layer of the surface was all that was left of the stabilizer and the remaining surface had returned to its natural soil state. The assumption is that this surface, because of its natural soil base, never got the opportunity to set up properly because it was installed in wetlands where the soil naturally maintains more moisture.

Photo 110 Polypavement trail segment started to show signs of cracking and softening after the first round of tests. July 6, 2007.

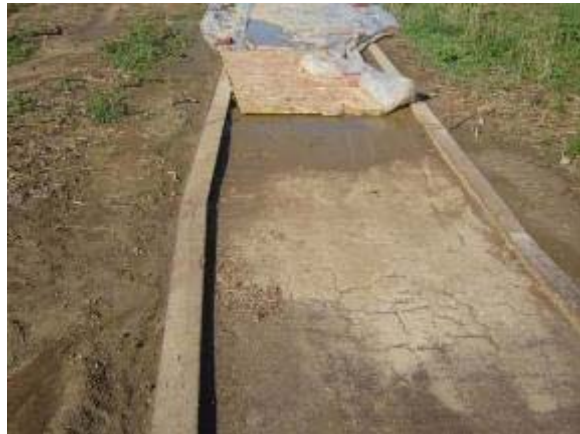
Photo 111 Polypavement trail segment started to show signs of cracking and softening after the first round of tests. July 6, 2007.

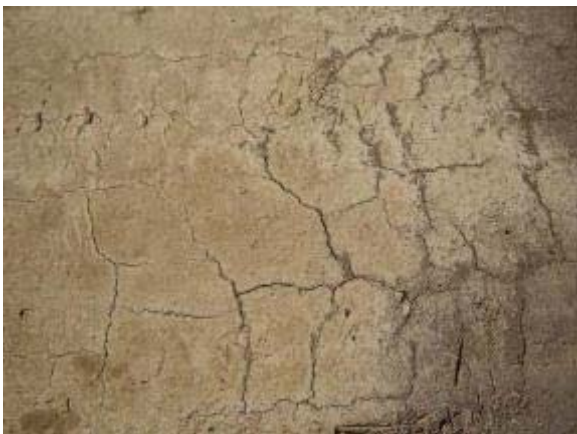
Photo 112 Polypavement trail segment shows cracking. July 6, 2007.

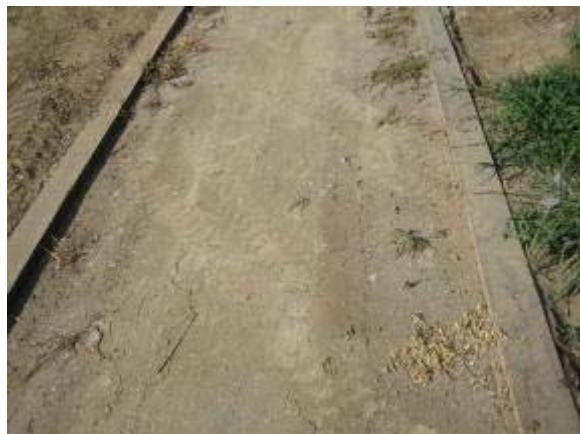
Photo 113 Polypavement trail segment after heavy rains remained cracked. August 9, 2007.

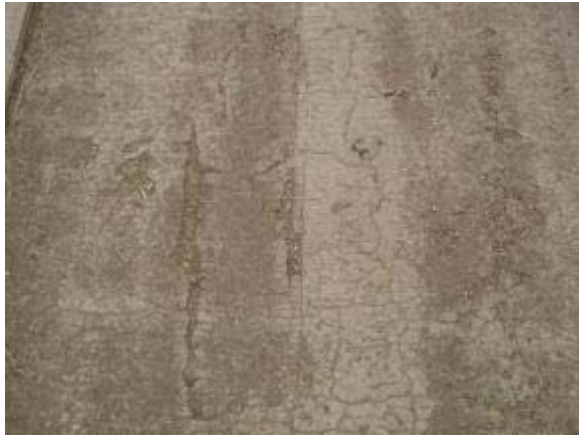
Photo 114 Polypavement trail segment with cracks and heaving along width of trail. October 19, 2007.

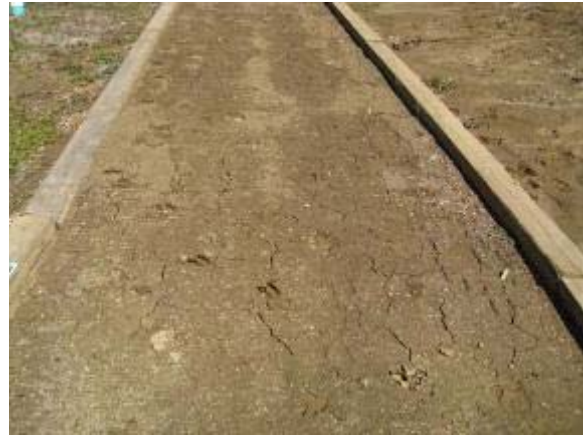
Photo 115 Polypavement trail segment would dry with cracks and heaving after heavy rail. March 13, 2008.

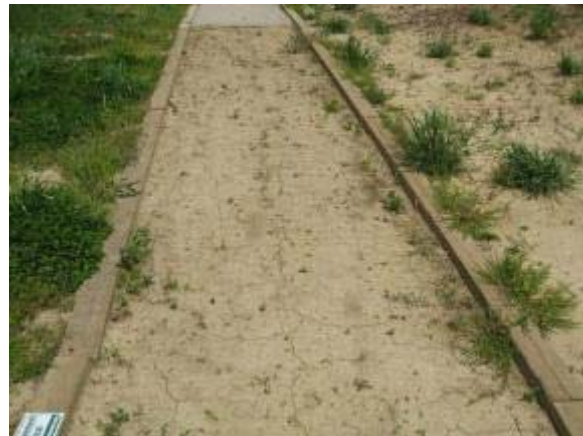
Photo 117 Polypavement trail segment shows cracks. May 6, 2008.

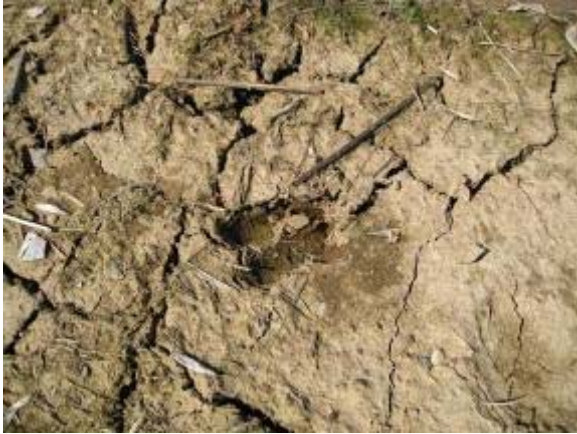
Photo 120 Polypavement trail segment may not have set up properly due to the moist soil of the wetlands. March 17, 2009.

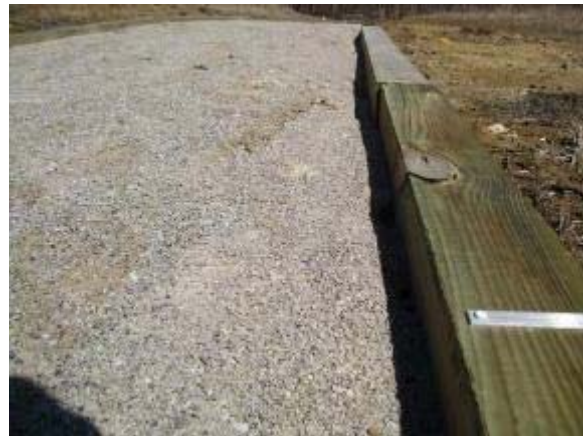
Photo 136 Quarter Inch Minus Limestone trail segment was loose under foot after heavy rainfall. March 13, 2008.

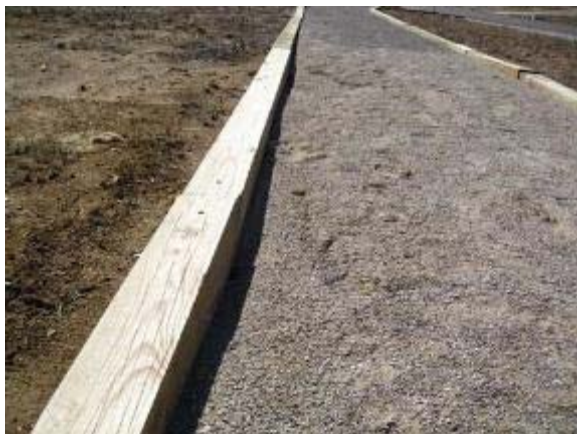
Photo 137 Quarter Inch Minus Limestone trail segment developed an erosion ditch. March 13, 2008.

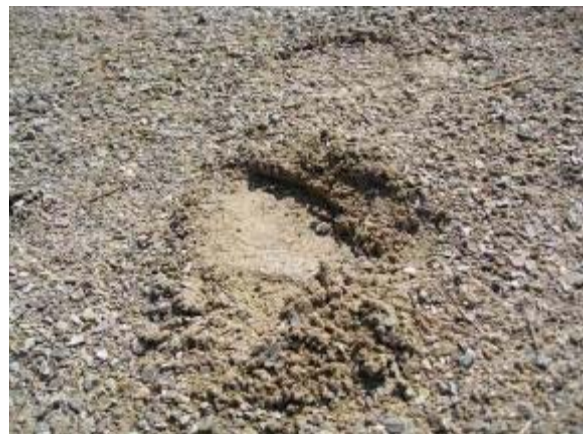
Photo 138 Quarter Inch Minus Limestone trail segment would only firm up after extended periods of no moisture. March 17, 2009.
