Rails-with-Trails:

A Preliminary Assessment of Safety and Grade Crossings

November 2005

Rails-to-Trails Conservancy

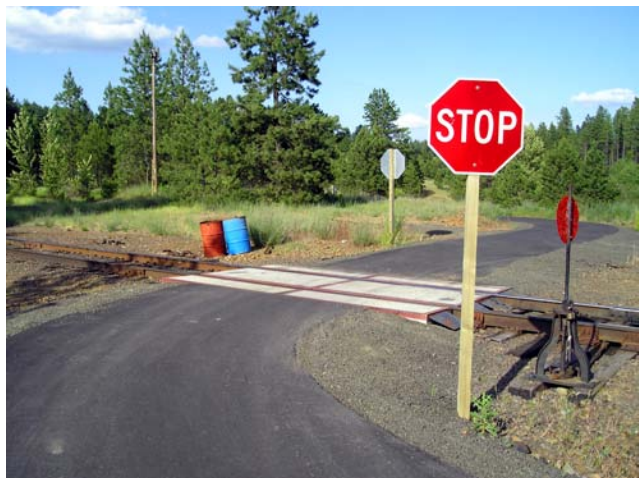
The 95 mile Trail of the Coeur d'Alene crosses the active St. Maries Railroad near Plummer. Safety devices are limited to railroad advance warning signs, stops signs, and a curve in the road to slow bicyclists. (Photo courtesy of Brian Momberg, RTC.)

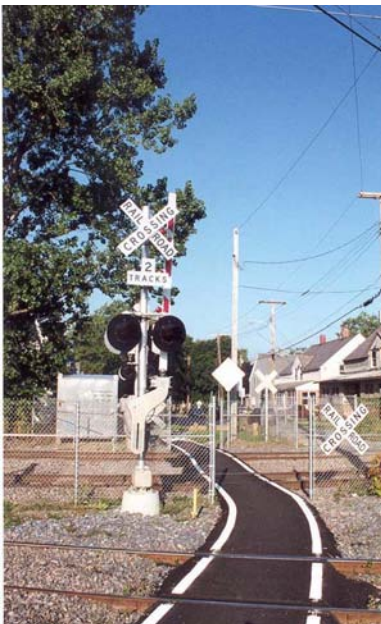
Along this trail in Burlington, Vermont, safety devices include cross bucks, flashing lights, a gate as well as a fence to encourage pedestrians to traverse the tracks at the designated crossing point.

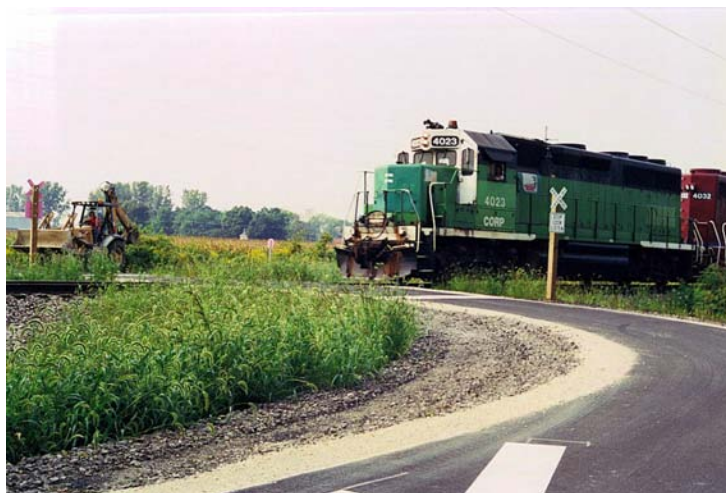
The Simon Kenton Trail in Ohio uses only cross bucks as safety devices. However, the trail curves intersecting the tracks at a right angle, slowing users and providing for an increased sight line. (Photo courtesy of Peggy Holland.)

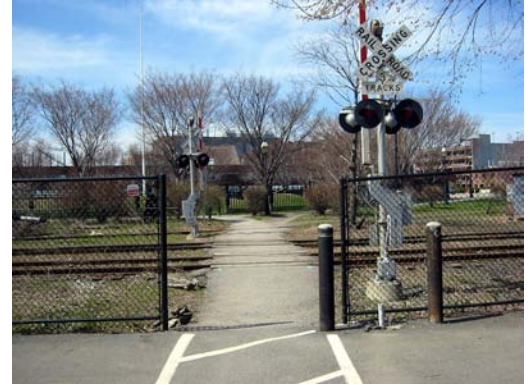
This crossing in Cambridge, Massachusetts includes cross bucks, flashing lights, a gate as well as a fence to encourage pedestrians to traverse the tracks at the designated crossing point. (Photo courtesy of Kelly Brown.)

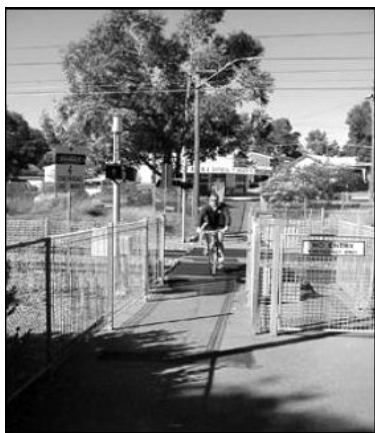
Perth Australia—City West Station. Automatic Swing Gate, which is normally open.

Automatic swing gates close and lock as a train approaches. It is desirable to have a safe place or an emergency exit button in case a pedestrian is caught inside the gates. There is also a need for a button for an emergency exit and a safe haven in case someone is trapped inside the gates

Our research failed to yield any known examples of automatic swing gates used on multi-use paths in the United States. There are examples of automatic swing gates in Australia these photos was taken at in Perth on the Fremantle Rail Line.

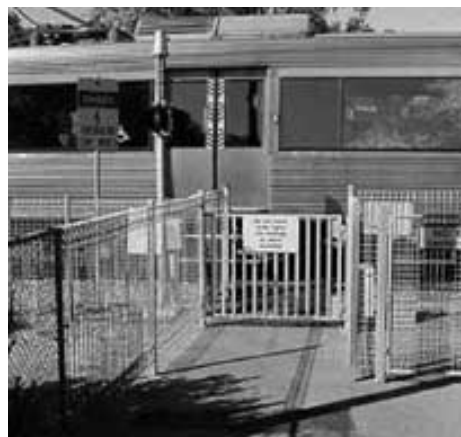
Gate closes automatically when a train approaches

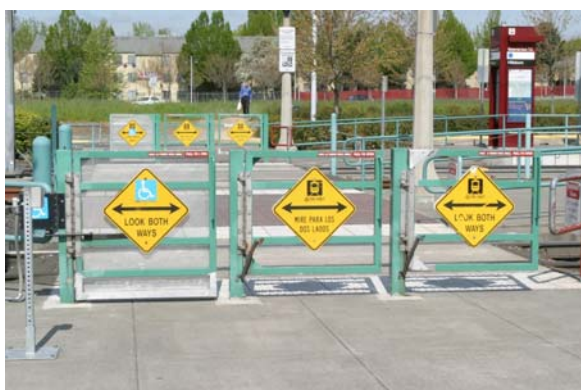
Beaverton, Oregon—Manual Swing Gate

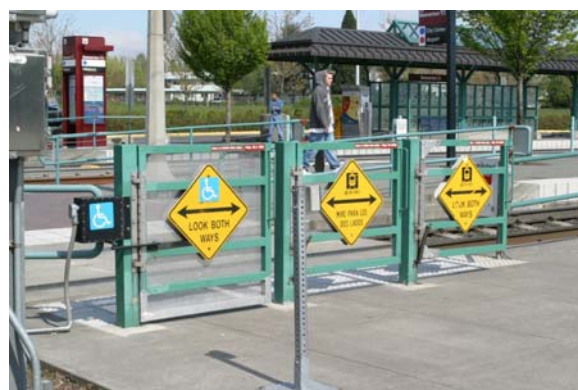
Disabled passengers and cyclists can use the push button control

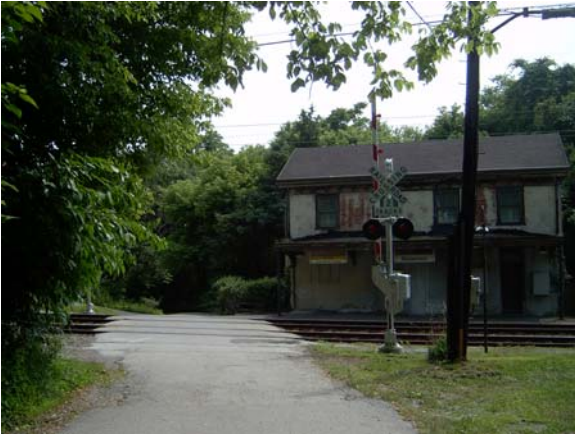
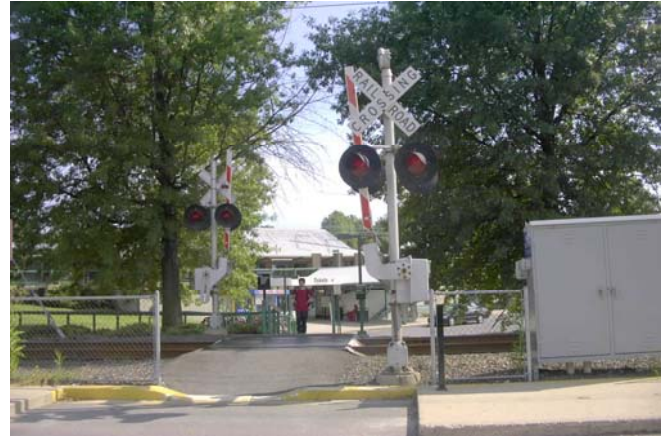
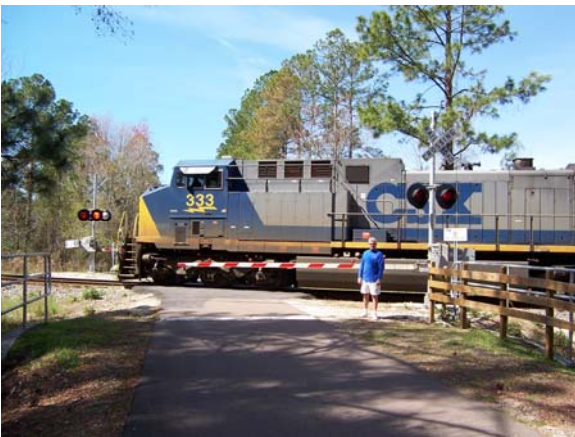
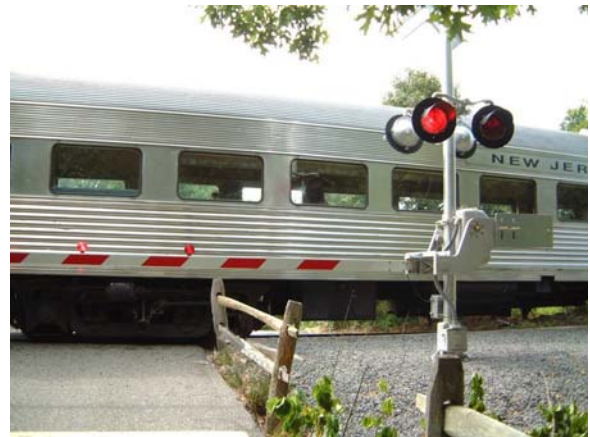
Warning lights and Automatic Gates

The standard drop down railroad gates that are also known as boom gates offer the next level of protection. There are several pedestrian grade crossings in and around Philadelphia where this is used including the Manayunk Canal Towpath at SEPTA's former Shawmont Station, Princeton Junction, Princeton Branch (Dinky Line) Rail Station and the Middle Township Bike Path at the 4H Fairgrounds in Cape May County Park, NJ.

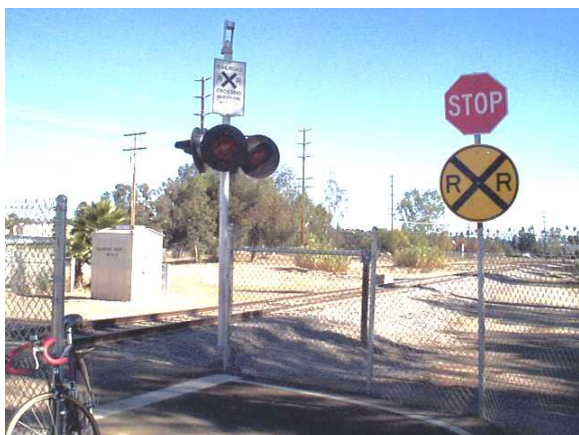
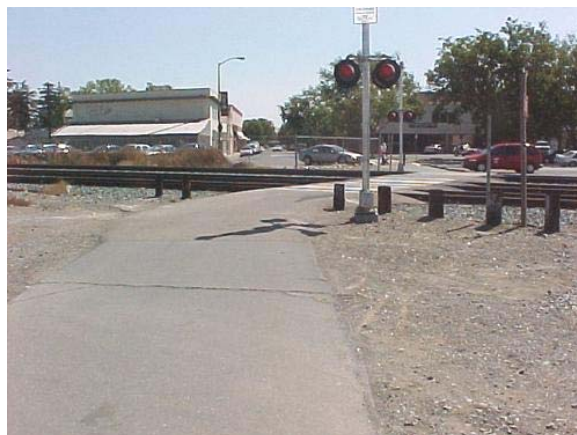
Warning Lights

Warning lights – Some crossings have warning lights and audible signals to warn pedestrians. Some pedestrian crossings are also constrained by link fencing which works to channel pedestrians to the crossing points.

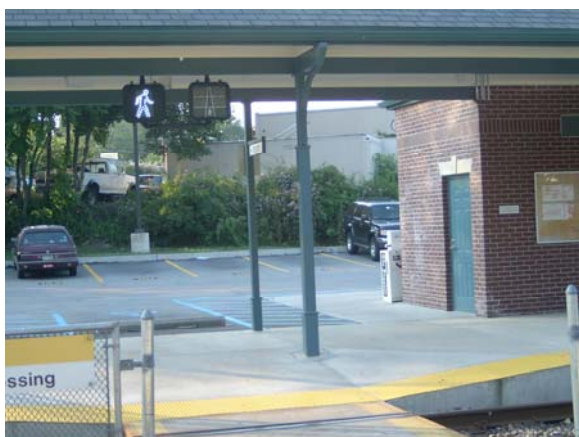
Philadelphia, PA-Somerton Station multi - directional warning signals.

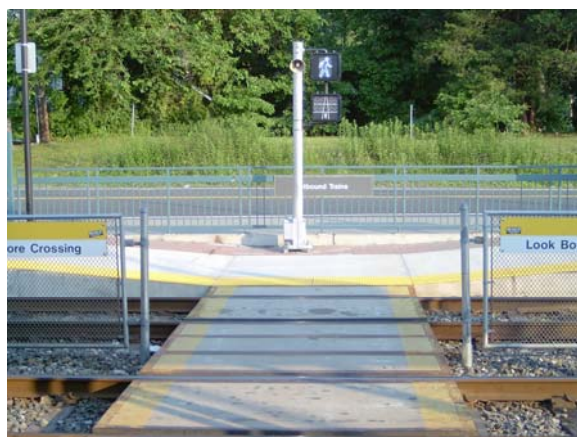
The audible device announces the approach of a train.

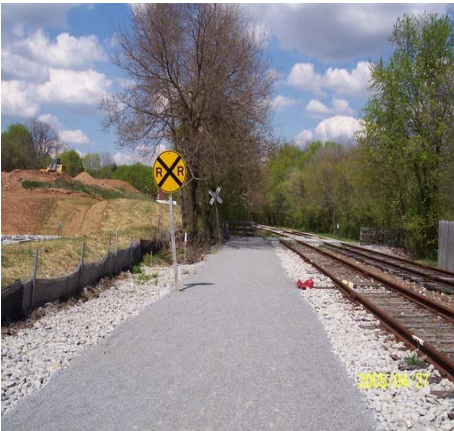
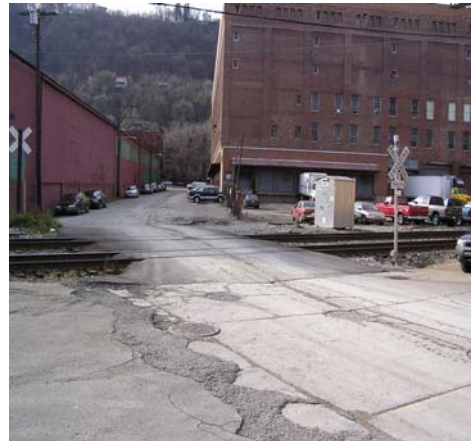
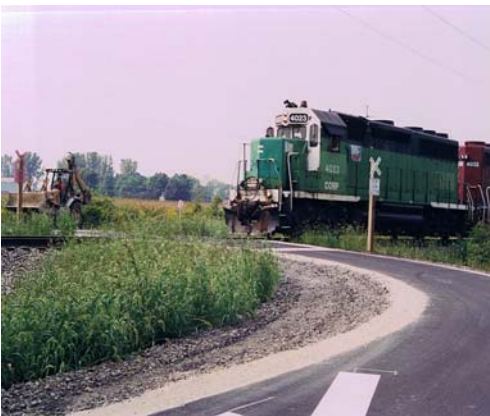
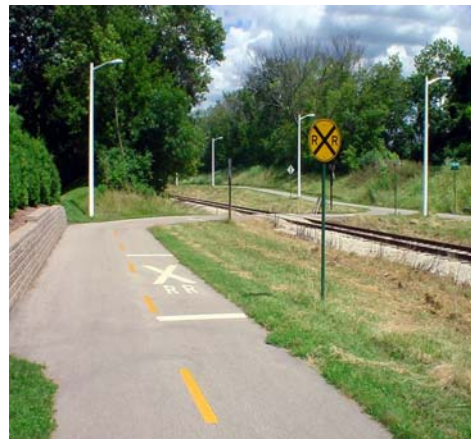
Non-Signalized Crossings

Non signalized crossings are the most common solution for multi-use paths when they cross low volume low speed freight railroads. Most have warning devices such as railroad crossbucks, pavement markings and signage. Some commuter rail stations simply have a “Look Both Ways” warning between inbound and outbound tracks.

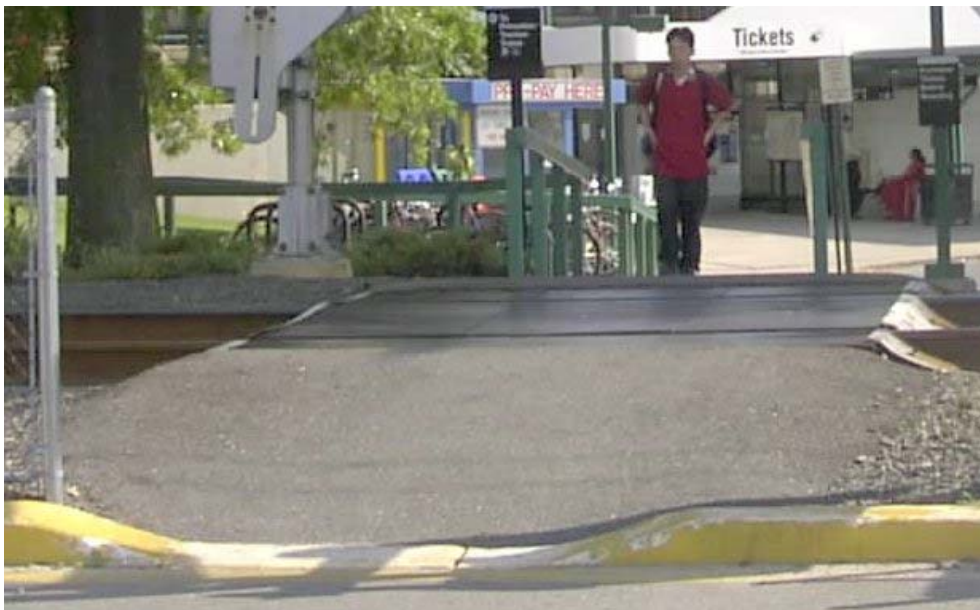
Example of an improved crossing Princeton Junction NJ

For bicycles and other wheeled devices a smooth crossing surface helps reduce the hazard of crossing rail tracks. Recommendations for grade crossing surface is published in the AASHTO *Guide for the Development of Bicycle Facilities*—Page 60:

“Railroad tracks present special hazards for bicycles and other narrow tired vehicles...Railroad-highway grade crossings should ideally be at a right angle to the rails. It is also important that the roadway approach be at the same elevation as the rails. Consideration should be given to the crossing surface materials and to the flangeway depth and width. Rubber or concrete crossing materials are longer lasting than wood or asphalt and require less maintenance.”

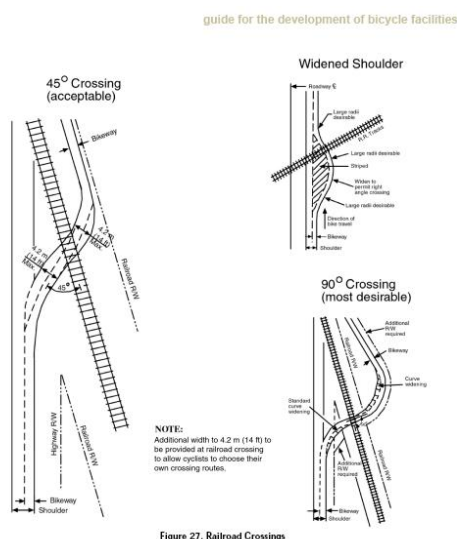
Left: AASHTO recommendations for paved paths at rail crossings.

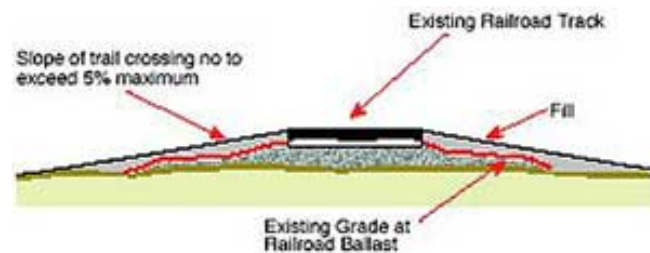
Above: AASHTO smoothness guidelines
