National Trail Surfaces Study

Final Report

February 2014

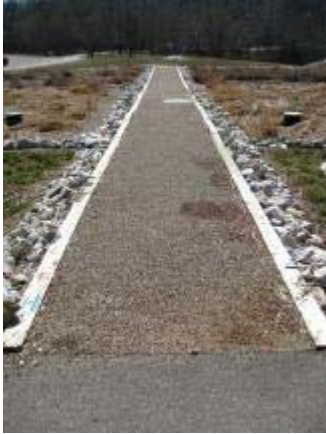
Photo 13 Klingstone almost two years after installation has small amount of loose fines coming to surface. March 17, 2009.

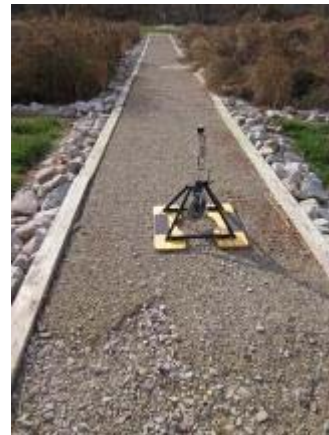
Photo 16 Klingstone at beginning of trail segment has started to wash out. November 22, 2011.

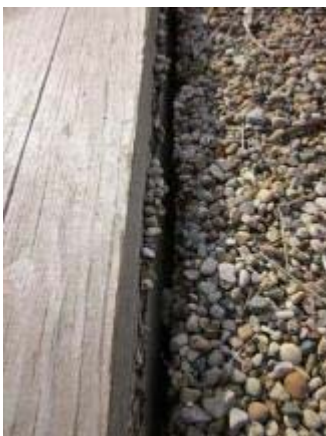
Photo 17 Klingstone surface has started to recede from timber edging. November 22, 2011.

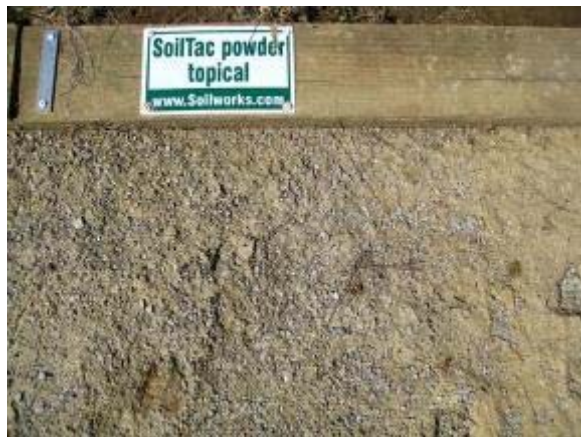
Photo 21 Soiltac Powder Topical has formed a solid paper-thin layer after a heavy rainfall. March 13, 2008.

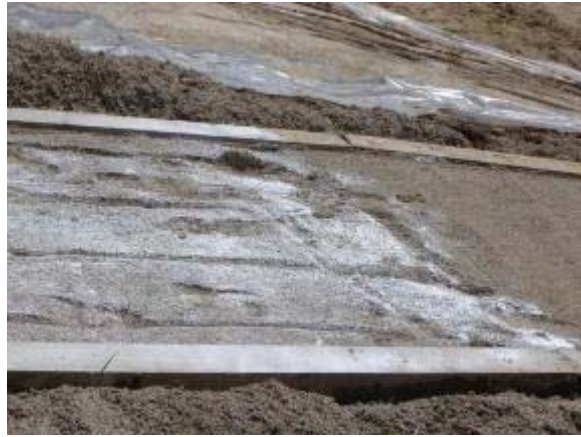
Photo 29 Soiltac Powder Mix-In is applied to a base of 2 inches of native soil. June 27, 2007.

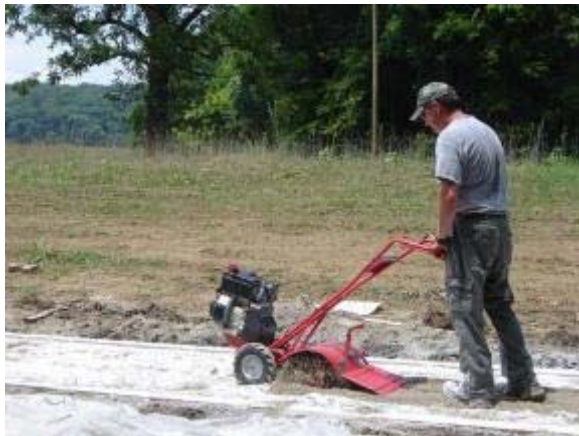
Photo 30 Soiltac Powder Mix-In is tilled into the 2 inch base of native soil. June 27, 2007.

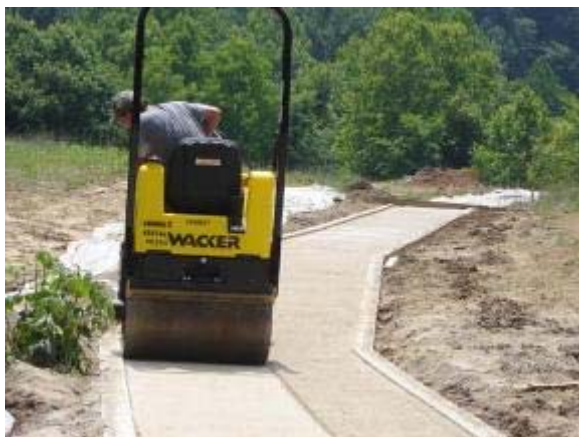
Photo 32 Soiltac Powder Mix-In is smoothed and compacted. June 27, 2007.

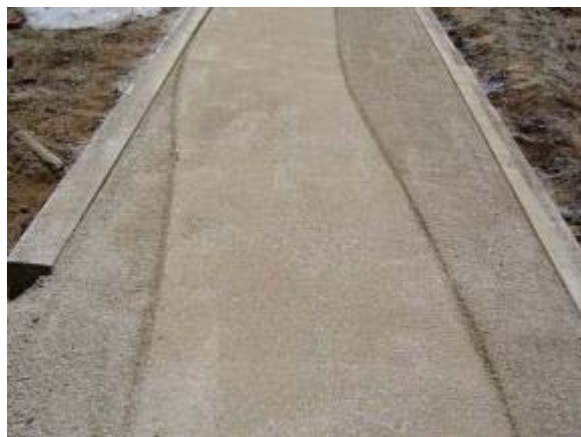
Photo 33 Soiltac Powder Mix-In is smoothed and compacted. June 27, 2007.

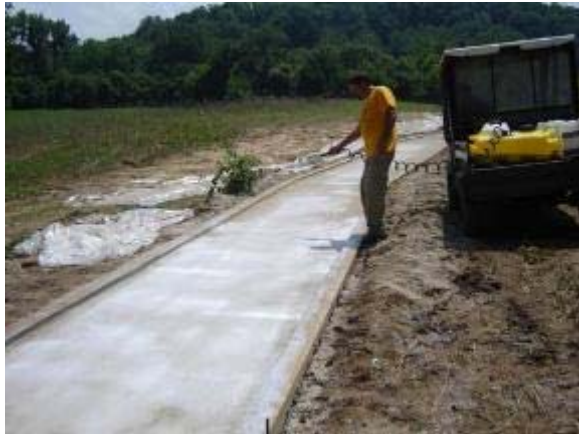
Photo 34 Soiltac Powder Mix-In is sprayed to seal the surface. June 27, 2007.

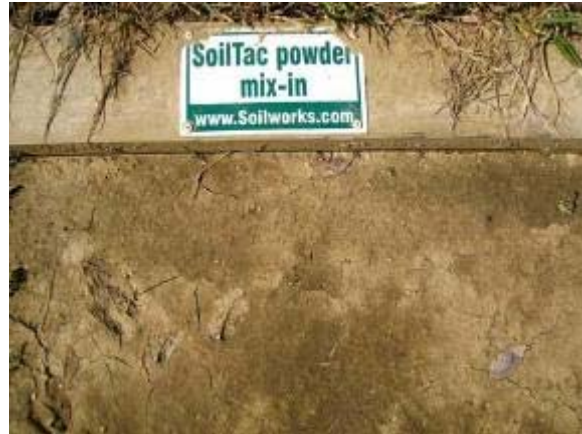
Photo 35 Soiltac Powder Mix-In almost a year after installation. March 13, 2008.

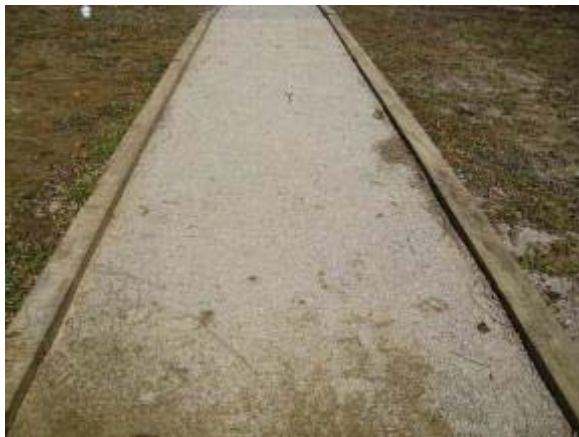
Photo 36 Soiltac Powder Mix-In trail segment maintained its condition a year after installation. March 13, 2008.

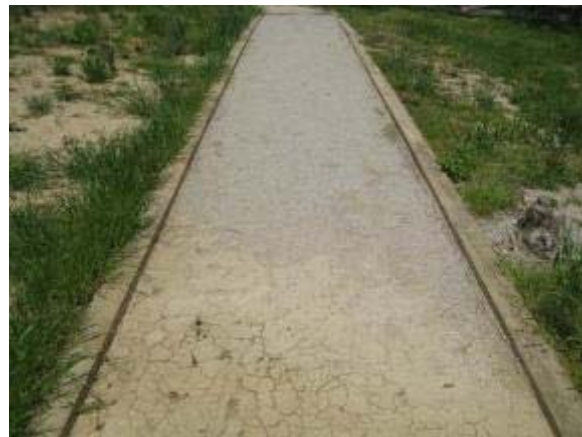
Photo 37 Soiltac Powder Mix-In softened surface would become firm again. May 6, 2008.

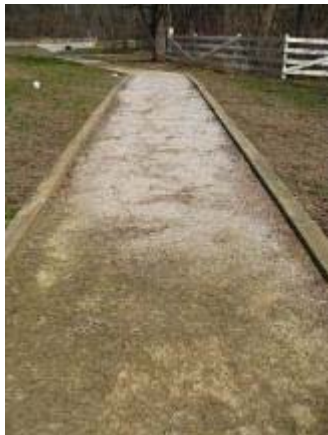
Photo 38 Soiltac Powder Mix-In almost two years after installation. March 17, 2009.

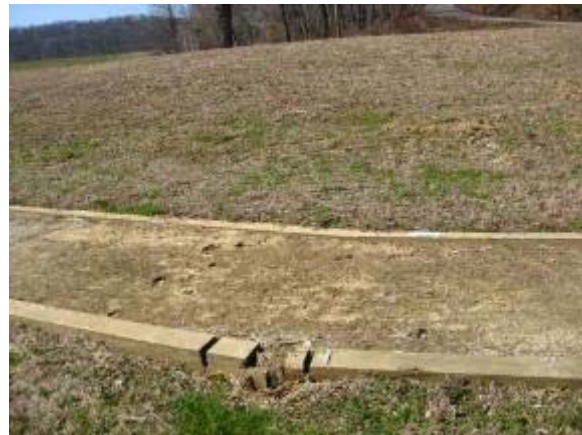
Photo 39 Soiltac Powder Mix-In does not have a constructed drainage mechanism considered appropriate for trail construction. March 17, 2009.

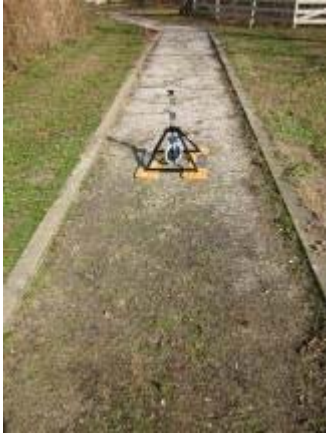
Photo 40 Soiltac Powder Mix-In showed only minor evidence of softening at the end of the study. November 2, 2011.

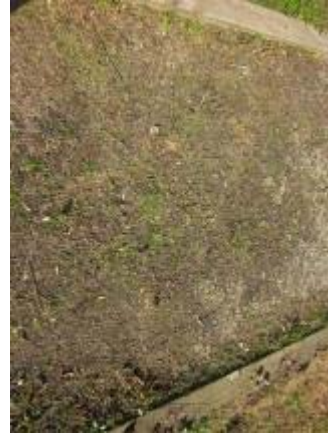
Photo 41 Soiltac Powder Mix-In trail segment with water crossing would soften and then return to natural surface state. November 2, 2011.

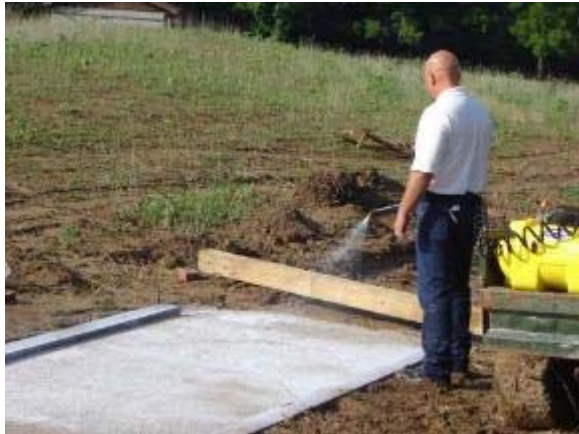
Photo 43 Soiltac Liquid Topical is applied to a base of 2 inch native soil, mixed with water and sprayed onto 4 inches of ¾ minus compacted limestone aggregate. June 27, 2007.

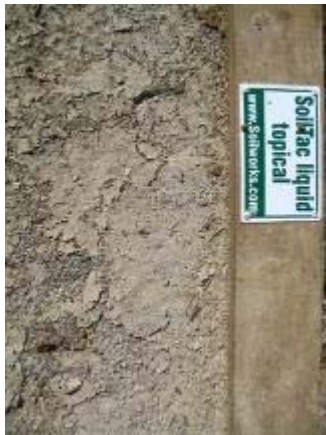
Photo 45 Soiltac Liquid Topical trail segment showed change after a heavy rainfall. March 13, 2008.

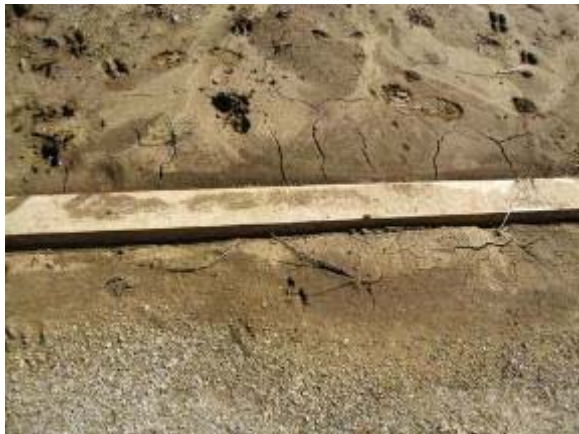
Photo 47 Soiltac Liquid Topical trail segment showed signs of runoff. March 13, 2008.

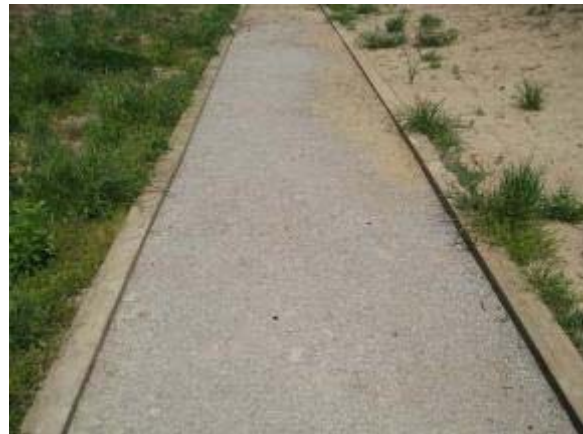
Photo 48 Soiltac Liquid Topical trail segment remained soft where water had pooled. May 6, 2008.

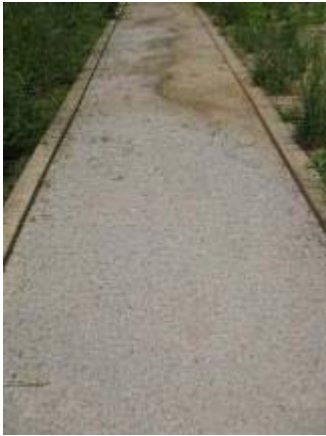
Photo 49 Soiltac Liquid Topical trail segment remained soft where water had pooled. June 12, 2008.

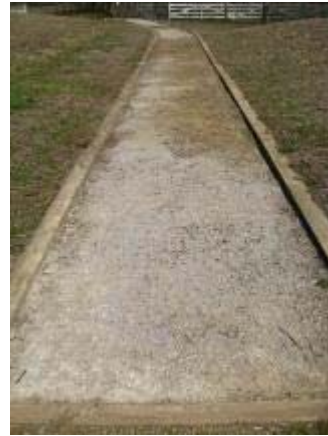
Photo 50 Soiltac Liquid Topical trail segment remained soft where water had pooled. March 17, 2009.

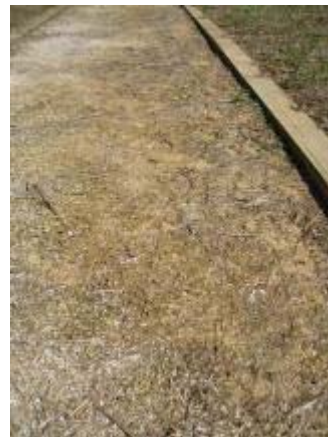
Photo 52 Soiltac Liquid Topical trail segment showed runoff. March 17, 2009.

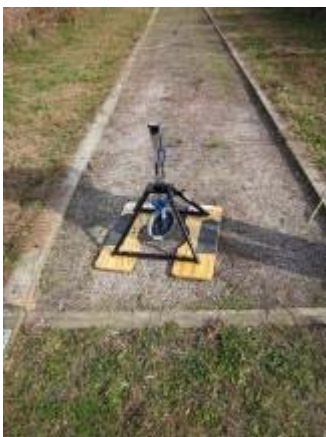
Photo 53 Soiltac Liquid Topical trail segment remained soft through the final testing. November 2, 2011.

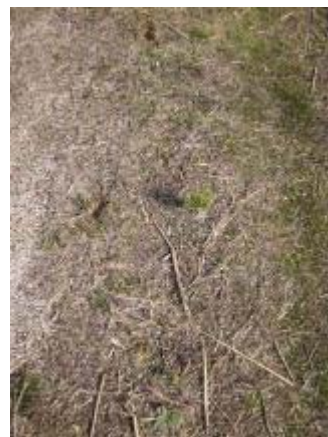
Photo 54 Soiltac Liquid Topical trail segment remained soft through the final testing. November 2, 2011.

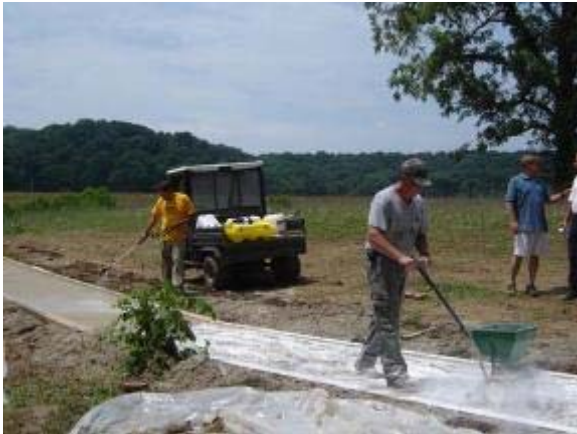
Photo 55 Soiltac Liquid Mix-In is applied to a base of 2 inches of native soil. June 27, 2007.

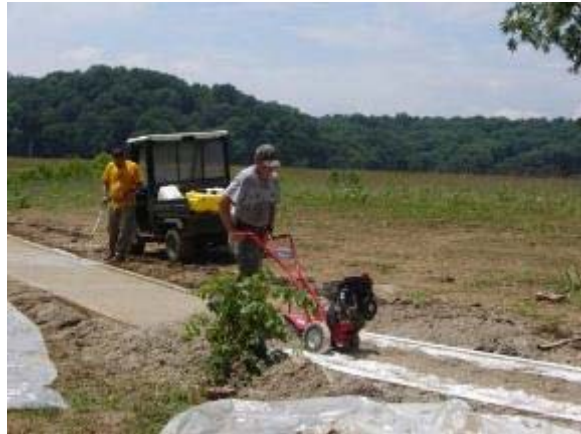
Photo 56 Soiltac Liquid Mix-In is then tilled into 4 inches of ¼ inch minus loose limestone aggregate. June 27, 2007.

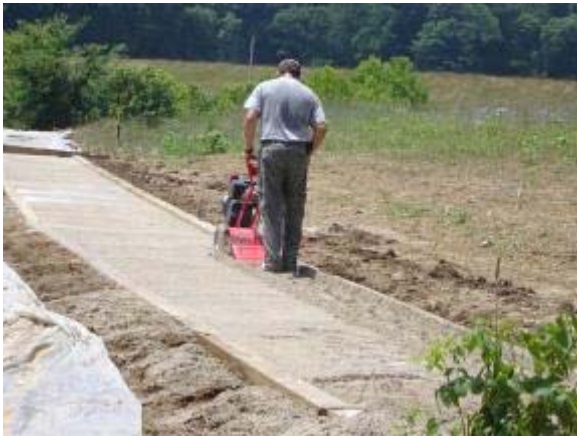
Photo 57 Soiltac Liquid Mix-In is then tilled into 4 inches of ¼ inch minus loose limestone aggregate. June 27, 2007.

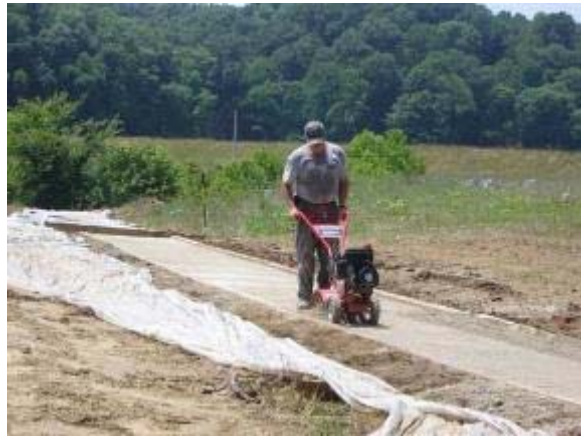
Photo 58 Soiltac Liquid Mix-In surface is tilled. June 27, 2007.

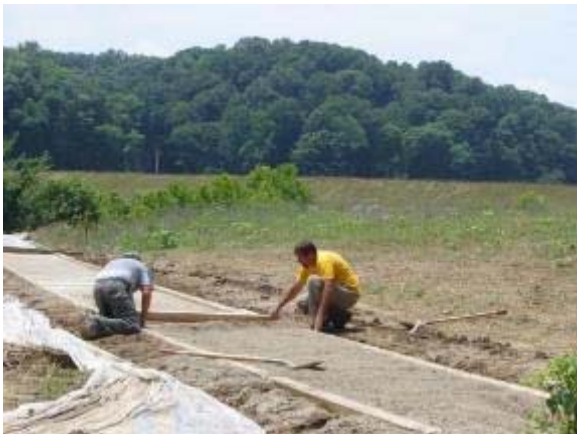
Photo 59 Soiltac Liquid Mix-In trail segment is leveled. June 27, 2007.

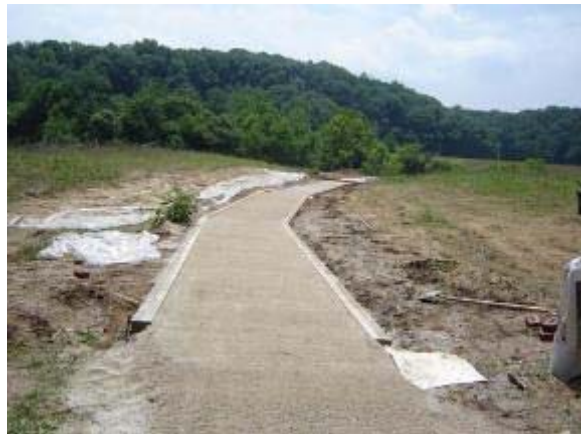
Photo 60 Soiltac Liquid Mix-In trail segment is prepared. June 27, 2007.

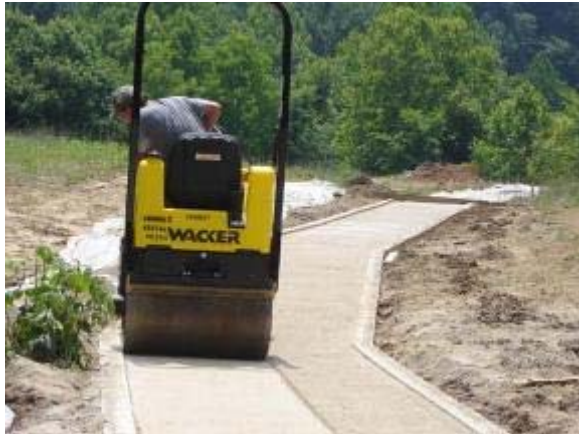
Photo 61 Soiltac Liquid Mix-In trail segment is compacted. June 27, 2007.

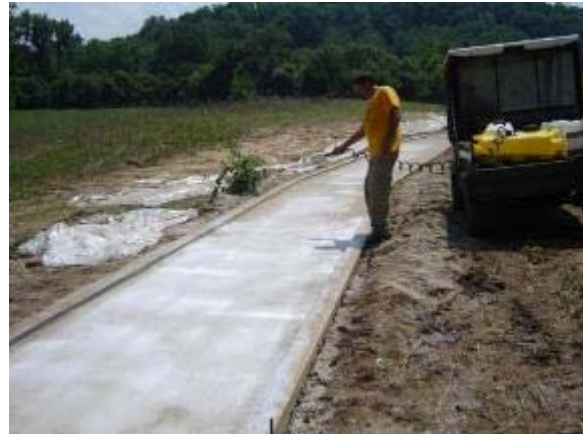
Photo 62 Soiltac Liquid Mix-In trail segment is sprayed to seal with a penetration of 4 inches. June 27, 2007.

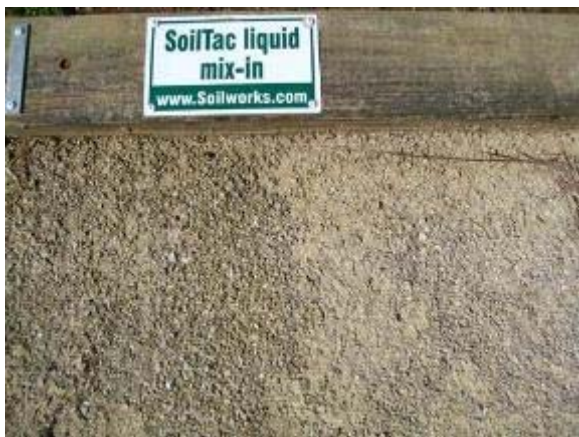
Photo 63 Soiltac Liquid Mix-In trail segment seemed to maintain itself well. March 13, 2008.

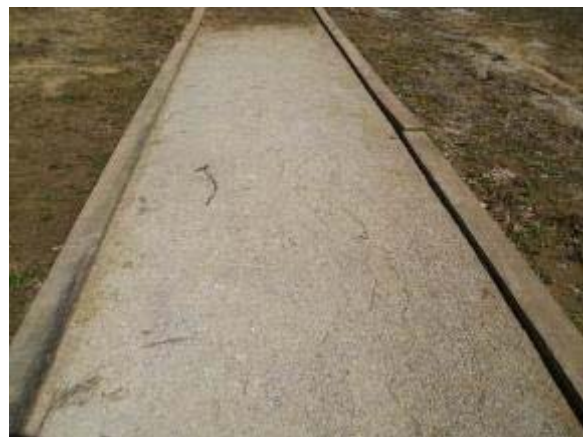
Photo 64 Soiltac Liquid Mix-In trail segment was only slightly soft under foot, showing footprint indentations. March 13, 2008.

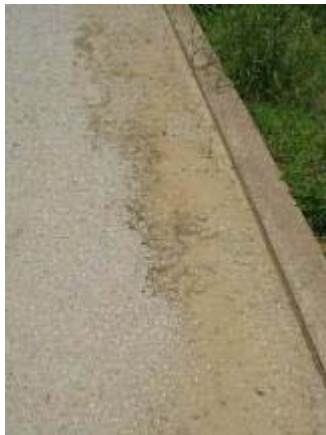
Photo 65 Soiltac Liquid Mix-In more than one year after installation seemed to maintain itself. June 12, 2008.

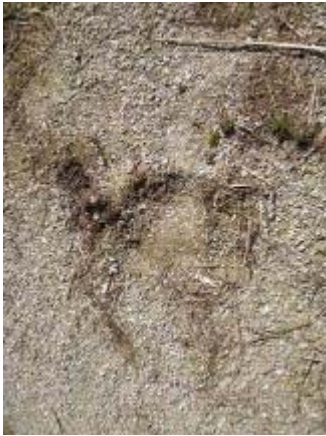
Photo 67 Soiltac Liquid Mix-In segment performed better than its topical application counterpart. March 17, 2009.

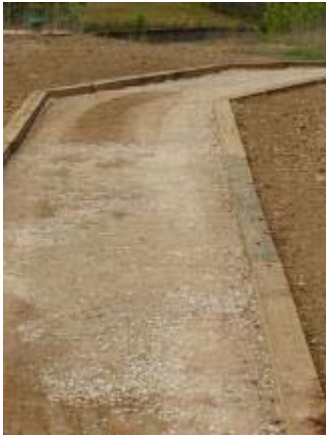
Photo 69 Stabilizer is applied to a base of 3 inches of compacted native soil. June 19, 2007.

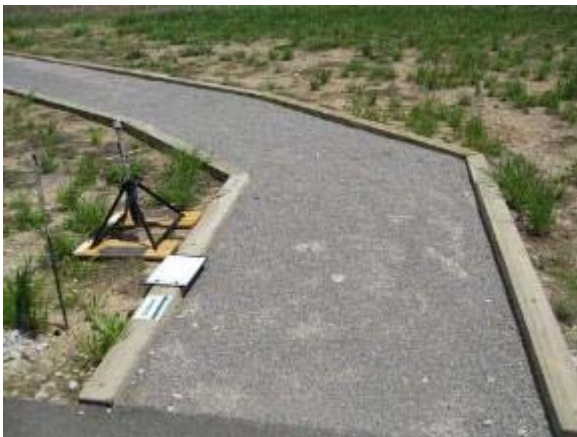
Photo 82 Stabilizer trail segment shows indentation from surface testing. March 13, 2008.

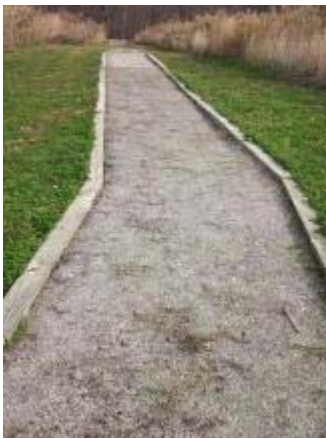
Photo 88 Stabilizer trail segment shows deterioration in middle of the trail. November 2, 2011.

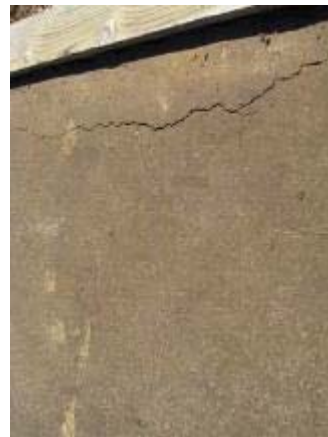
Photo 98 StaLok trail surface had a pattern of wear and repairing itself. March 13, 2008.

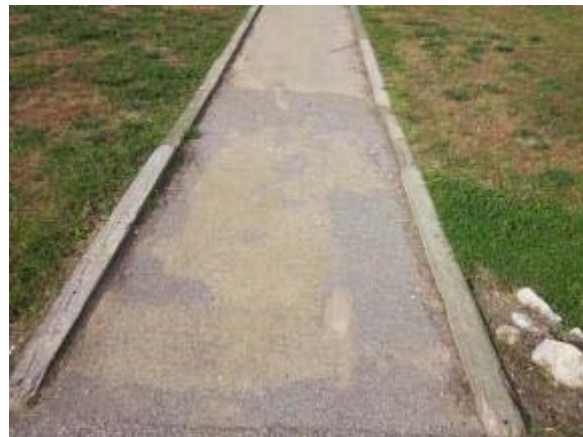
Photo 106 StaLok trail segment had some pooling of water at lower points of the surface. November 2, 2011.

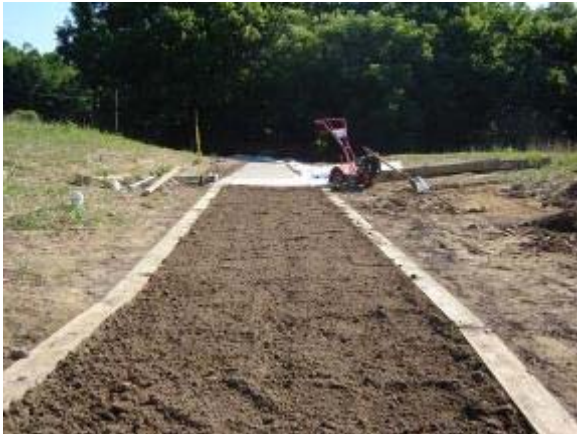
Photo 107 StaLok trail segment with pooling of water. November 2, 2011.

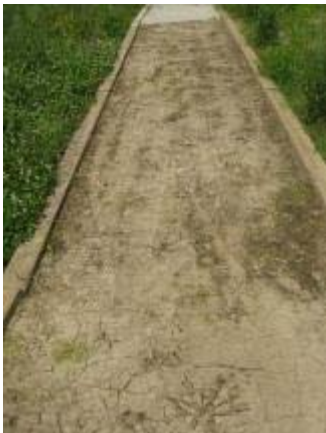
Photo 117 Polypavement trail segment shows cracks. May 6, 2008.

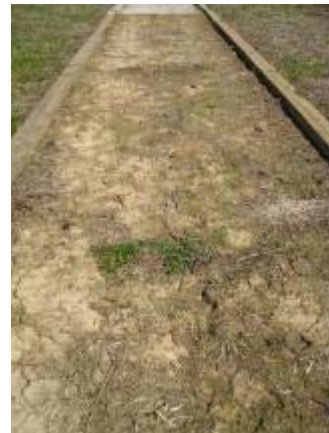
Photo 118 Polypavement trail segment a year after installation shows top layer is all that is left of the stabilizer. June 12, 2008.

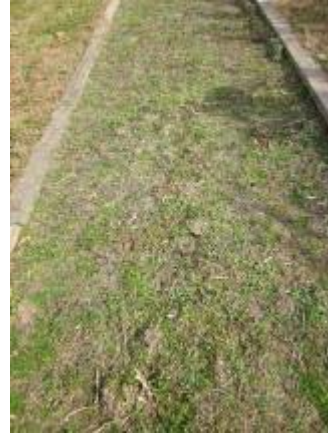
Photo 120 Polypavement trail segment may not have set up properly due to the moist soil of the wetlands. March 17, 2009.

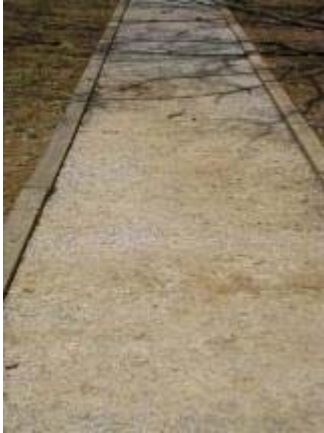
Photo 127 Three Quarter Inch Minus Limestone with 50 percent dust after two lifts installed and compacted. August 6, 2007.

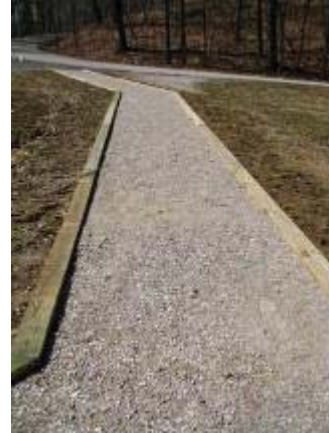
Photo 128 Three Quarter Inch Minus Limestone trail segment where water pooled after rain. March 13, 2008.

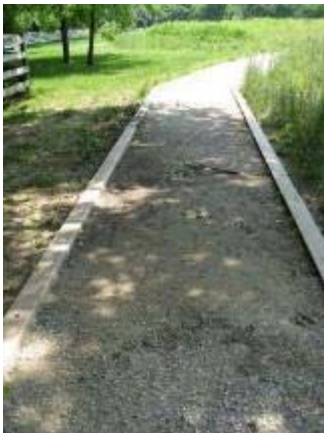
Photo 130 Three Quarter Inch Minus Limestone trail segment almost one year after installation. June 12, 2008.

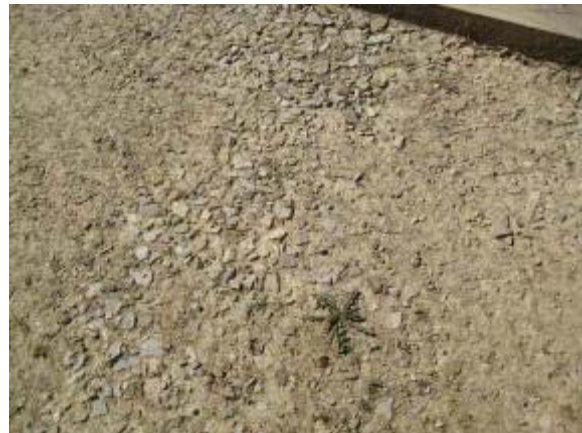
Photo 131 Three Quarter Inch Minus Limestone trail segment remained firm under foot. March 17, 2009.

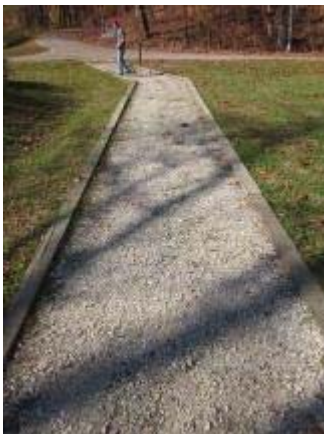
Photo 132 Three Quarter Inch Minus Limestone trail segment showed prevalence of larger fines working their way to the surface. November 2, 2011.

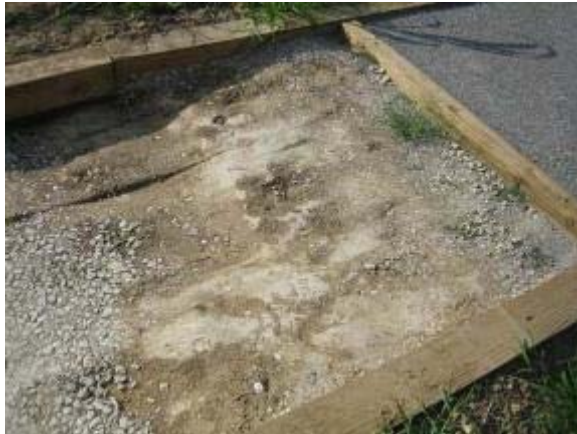
Photo 133 Quarter Inch Minus Limestone was installed in two rolled and compacted 3 inch lifts. August 9, 2007.

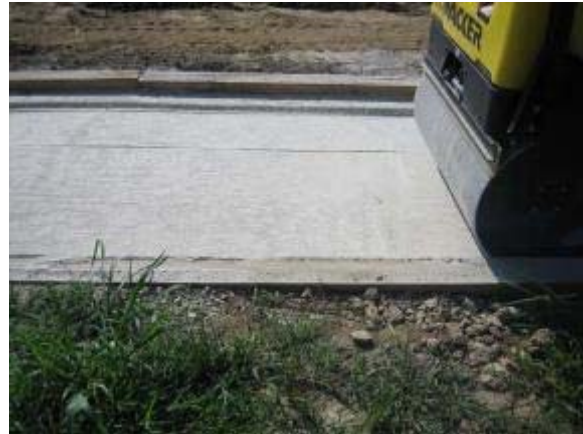
Photo 134 Quarter Inch Minus Limestone trail segment as second lift is rolled and compacted. August 9, 2007.

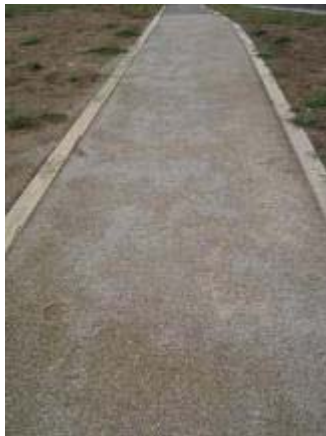
Photo 135 Quarter Inch Minus Limestone trail segment maintained itself in dry temperatures. October 19, 2007.

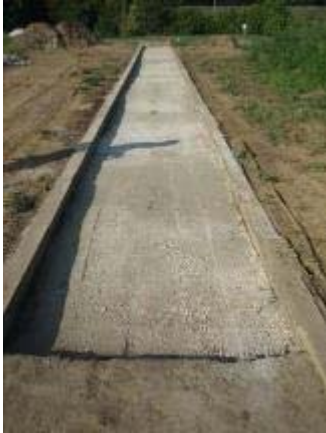
Photo 139 Three Quarter Inch Minus Base and Quarter Inch Minus Top Limestone trail segment is composed of 4 inch base; and a 2 inch top-dressing. August 9, 2007.

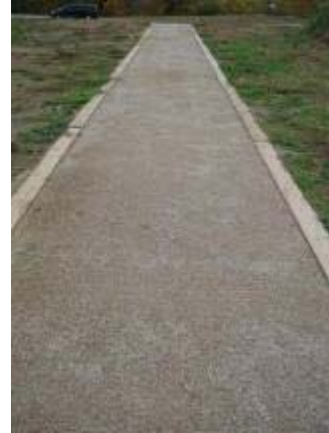
Photo 140 Three Quarter Inch Minus Base and Quarter Inch Minus Top Limestone trail segment maintained itself in dry temperatures. October 19, 2007.

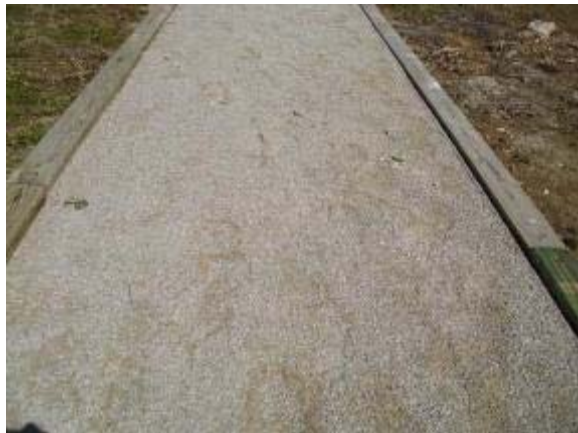
Photo 141 Three Quarter Inch Minus Base and Quarter Inch Minus Top Limestone trail segment after heavy rain. March 13, 2008.

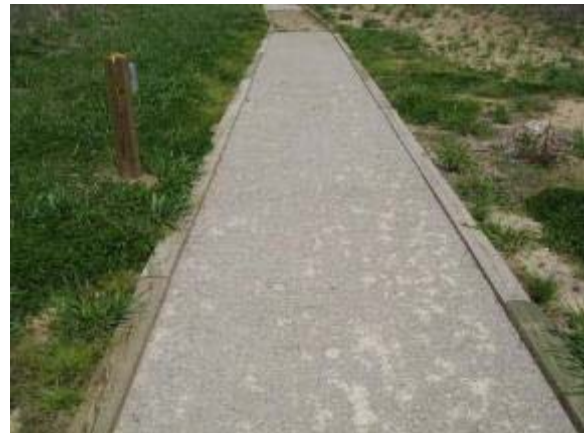
Photo 142 Three Quarter Inch Minus Base and Quarter Inch Minus Top Limestone trail segment firmed back up more quickly than the ¼ inch surface. May 6, 2008.

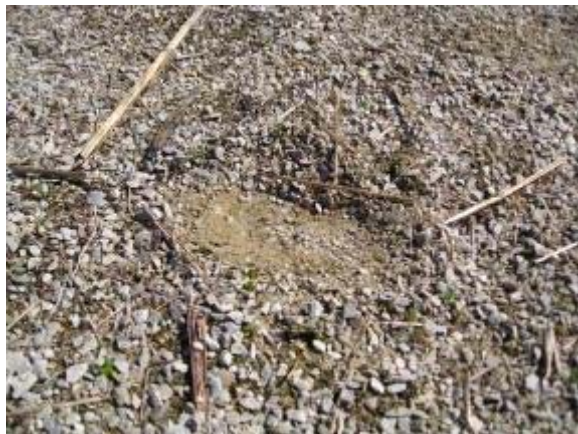
Photo 143 Three Quarter Inch Minus Base and Quarter Inch Minus Top Limestone trail segment showed signs of footprints after heavy rain. March 17, 2009.

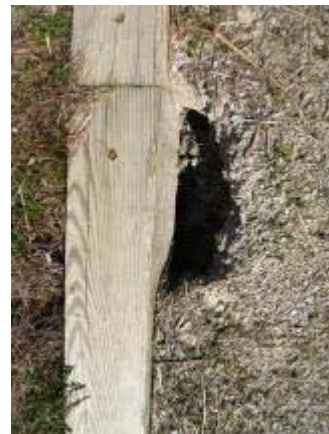
Photo 144 Three Quarter Inch Minus Base and Quarter Inch Minus Top Limestone trail segment after heavy rain. March 17, 2009.

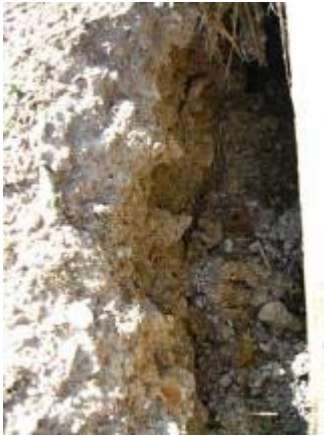
Photo 145 Three Quarter Inch Minus Base and Quarter Inch Minus Top Limestone trail segment after heavy rain. March 17, 2009.

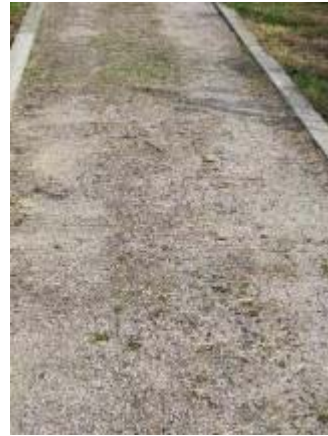
Photo 146 Three Quarter Inch Minus Base and Quarter Inch Minus Top Limestone trail segment became firm and stable under foot more quickly than the ¼ inch surface. November 2, 2011.
