National Trail Surfaces Study

Final Report

February 2014

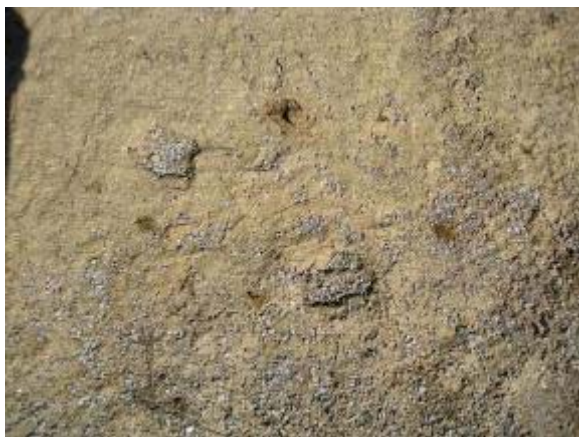
Photo 22 Soiltac Powder Topical was soft under foot and showed footprints. March 13, 2008.

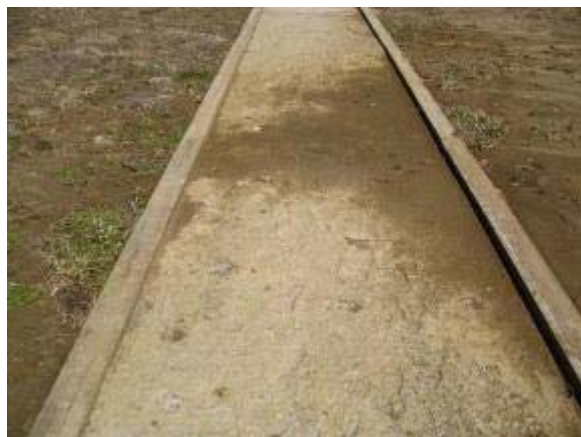
Photo 23 Soiltac Powder Topical with runoff from adjacent landscape. March 13, 2008.

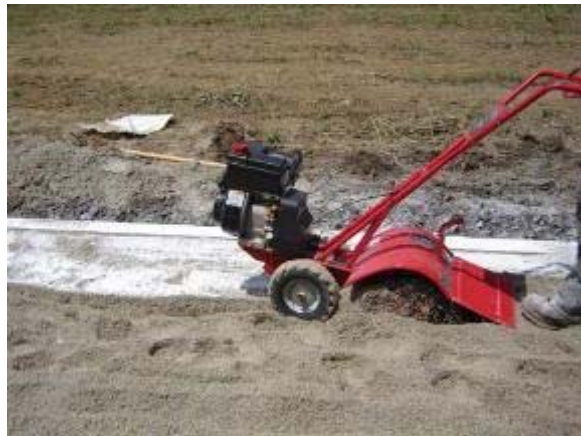
Photo 31 Soiltac Powder Mix-In has a penetration depth of 4 inches. June 27, 2007.

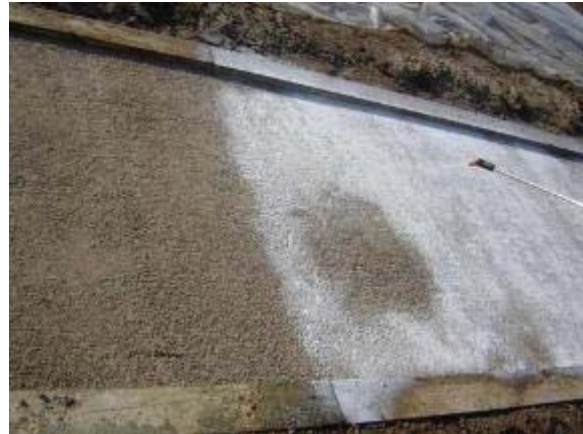
Photo 44 Soiltac Liquid Topical has a penetration depth of 1/8 inch. June 27, 2007.

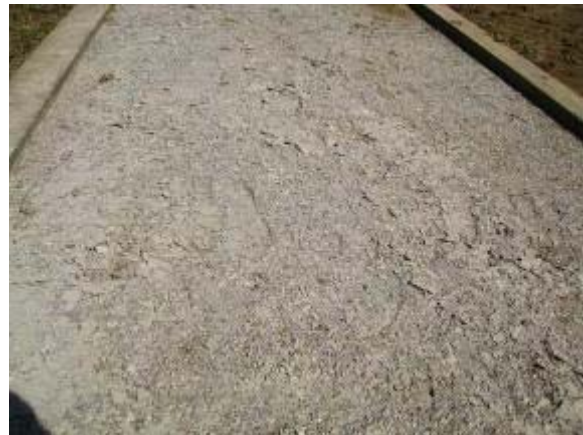
Photo 46 Soiltac Liquid Topical trail segment became soft under foot. March 13, 2008.

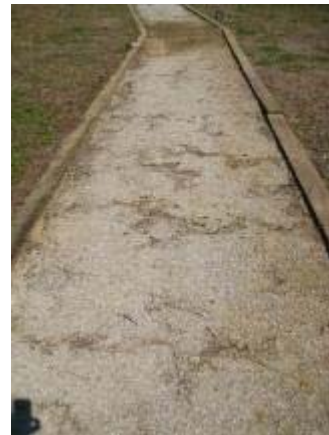
Photo 66 Soiltac Liquid Mix-In almost two years after installation. March 17, 2009.

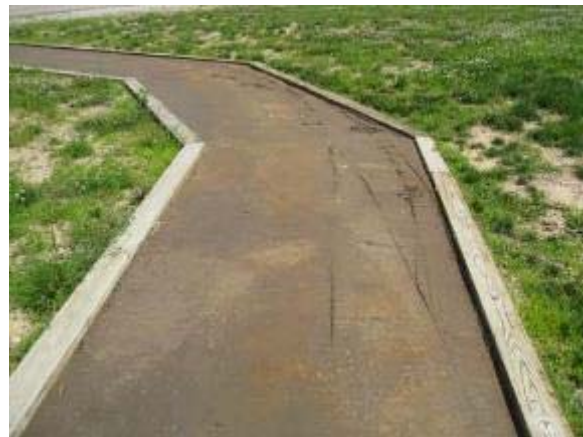
Photo 100 StaLok trail segment was noted for showing indentations and then repairing itself. May 6, 2008.

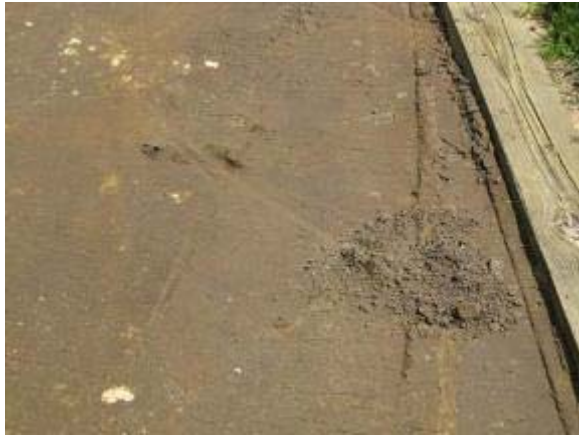
Photo 101 StaLok trail segment with wheelchair marks would repair itself. June 12, 2008.

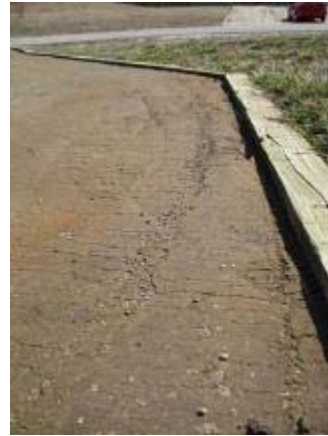
Photo 102 StaLok trail segment with wheelchair marks would repair itself. June 12, 2008.

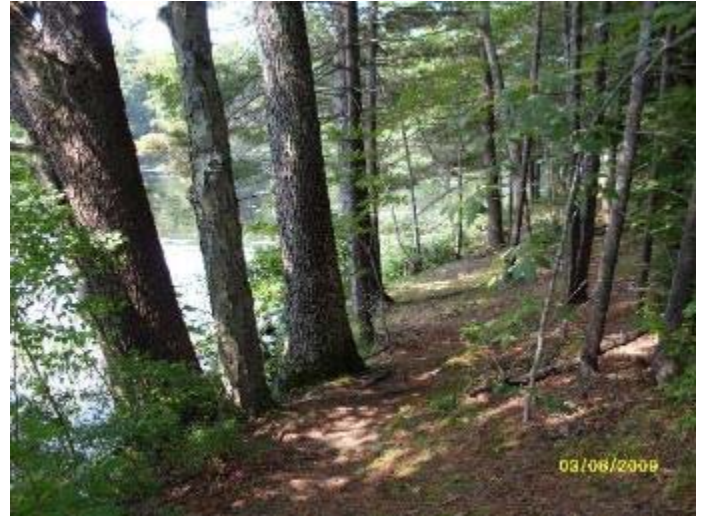
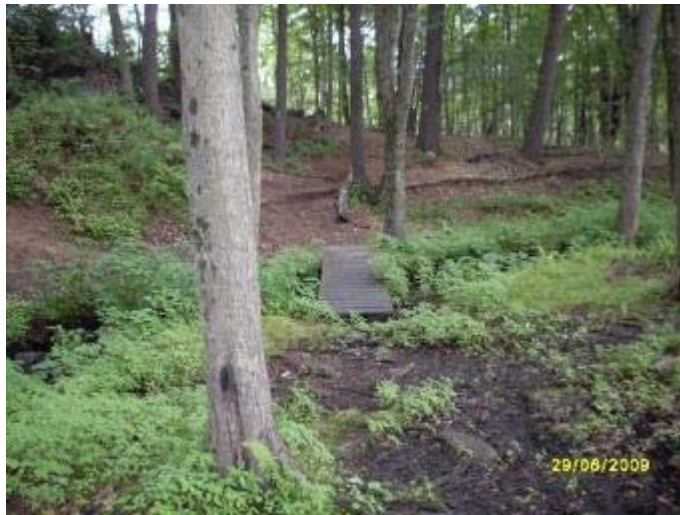
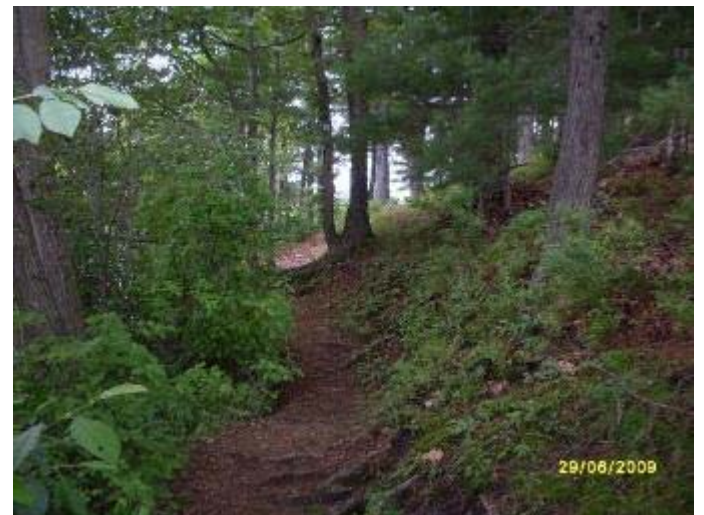
Massachusetts

Natural/native soil—not recommended surface

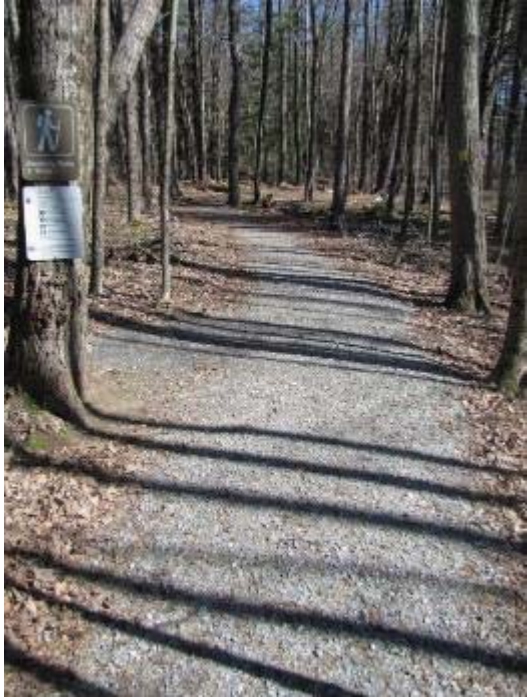
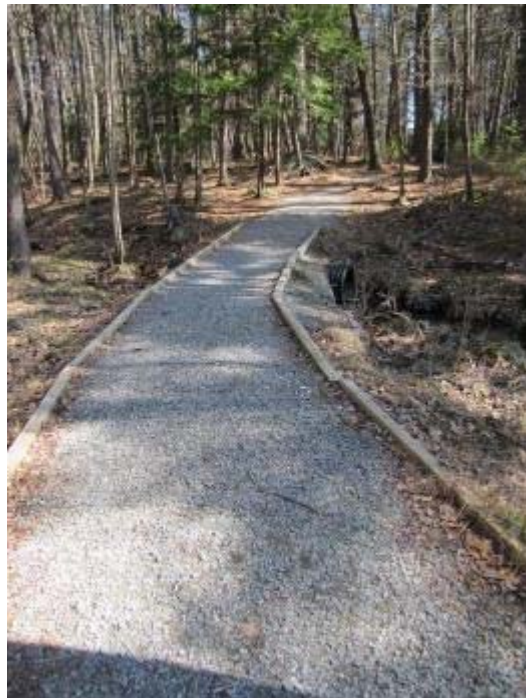
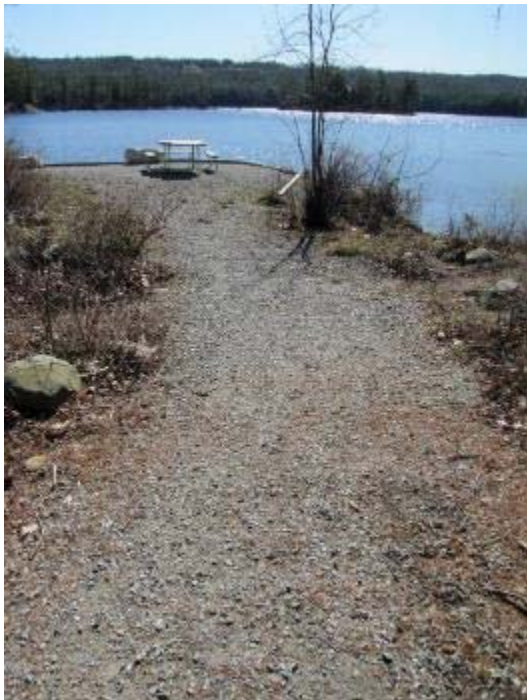
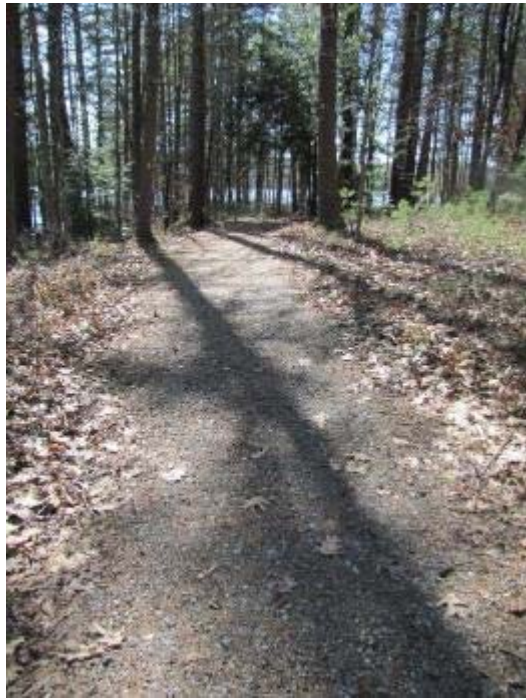
Massachusetts

Natural/native soil—recommended surface

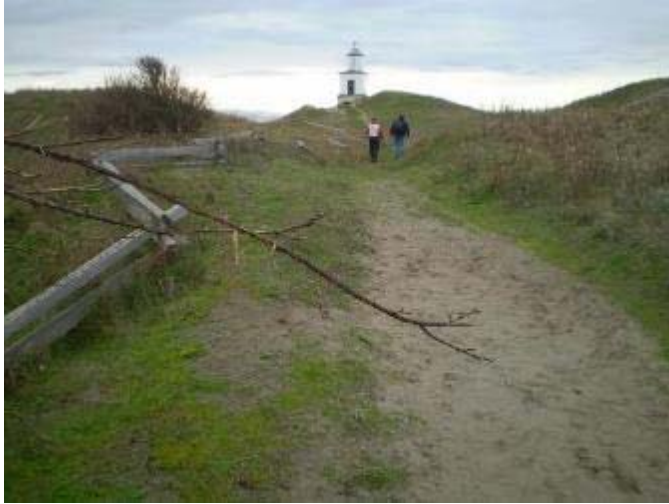
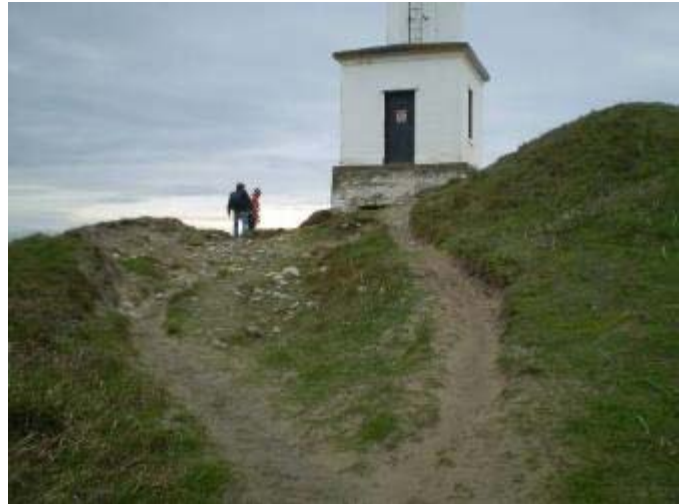
Washington

Natural soil/sandy loam—no recommendation provided

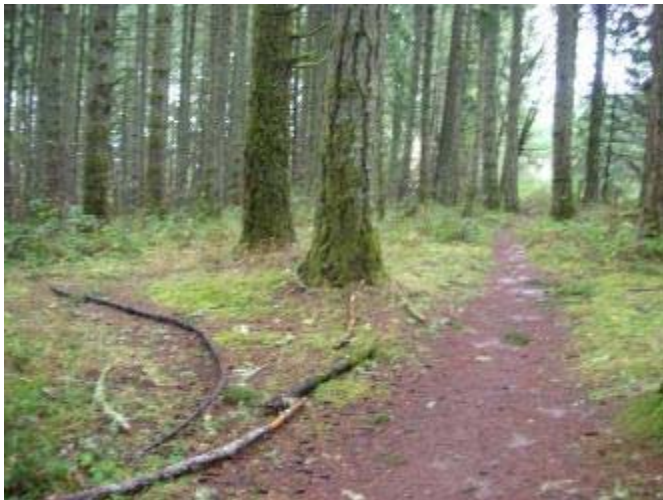
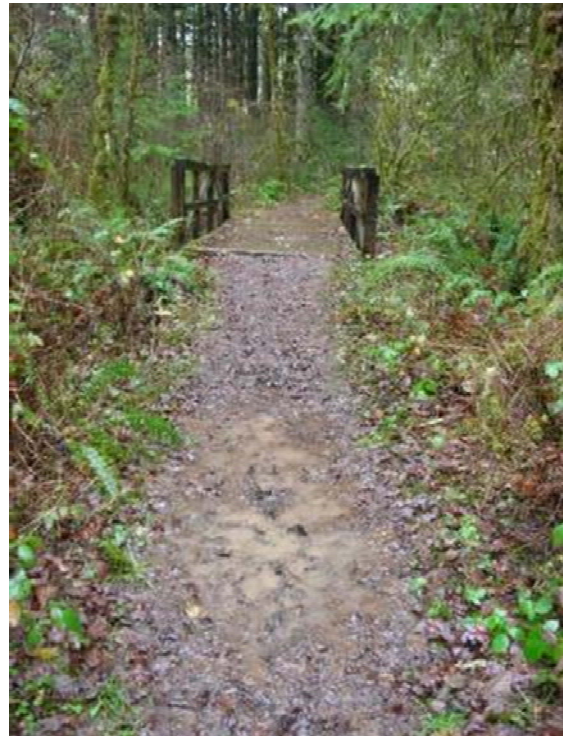
Oregon

Natural/native soil—not recommended surface
